**Tasmanian Geological Survey**  
**Record 2007/04**

# **Lawrence Vale Landslide Investigations: implications for landslide hazard assessment in Launceston**

*by A. R. Ezzy and C. Mazengarb*

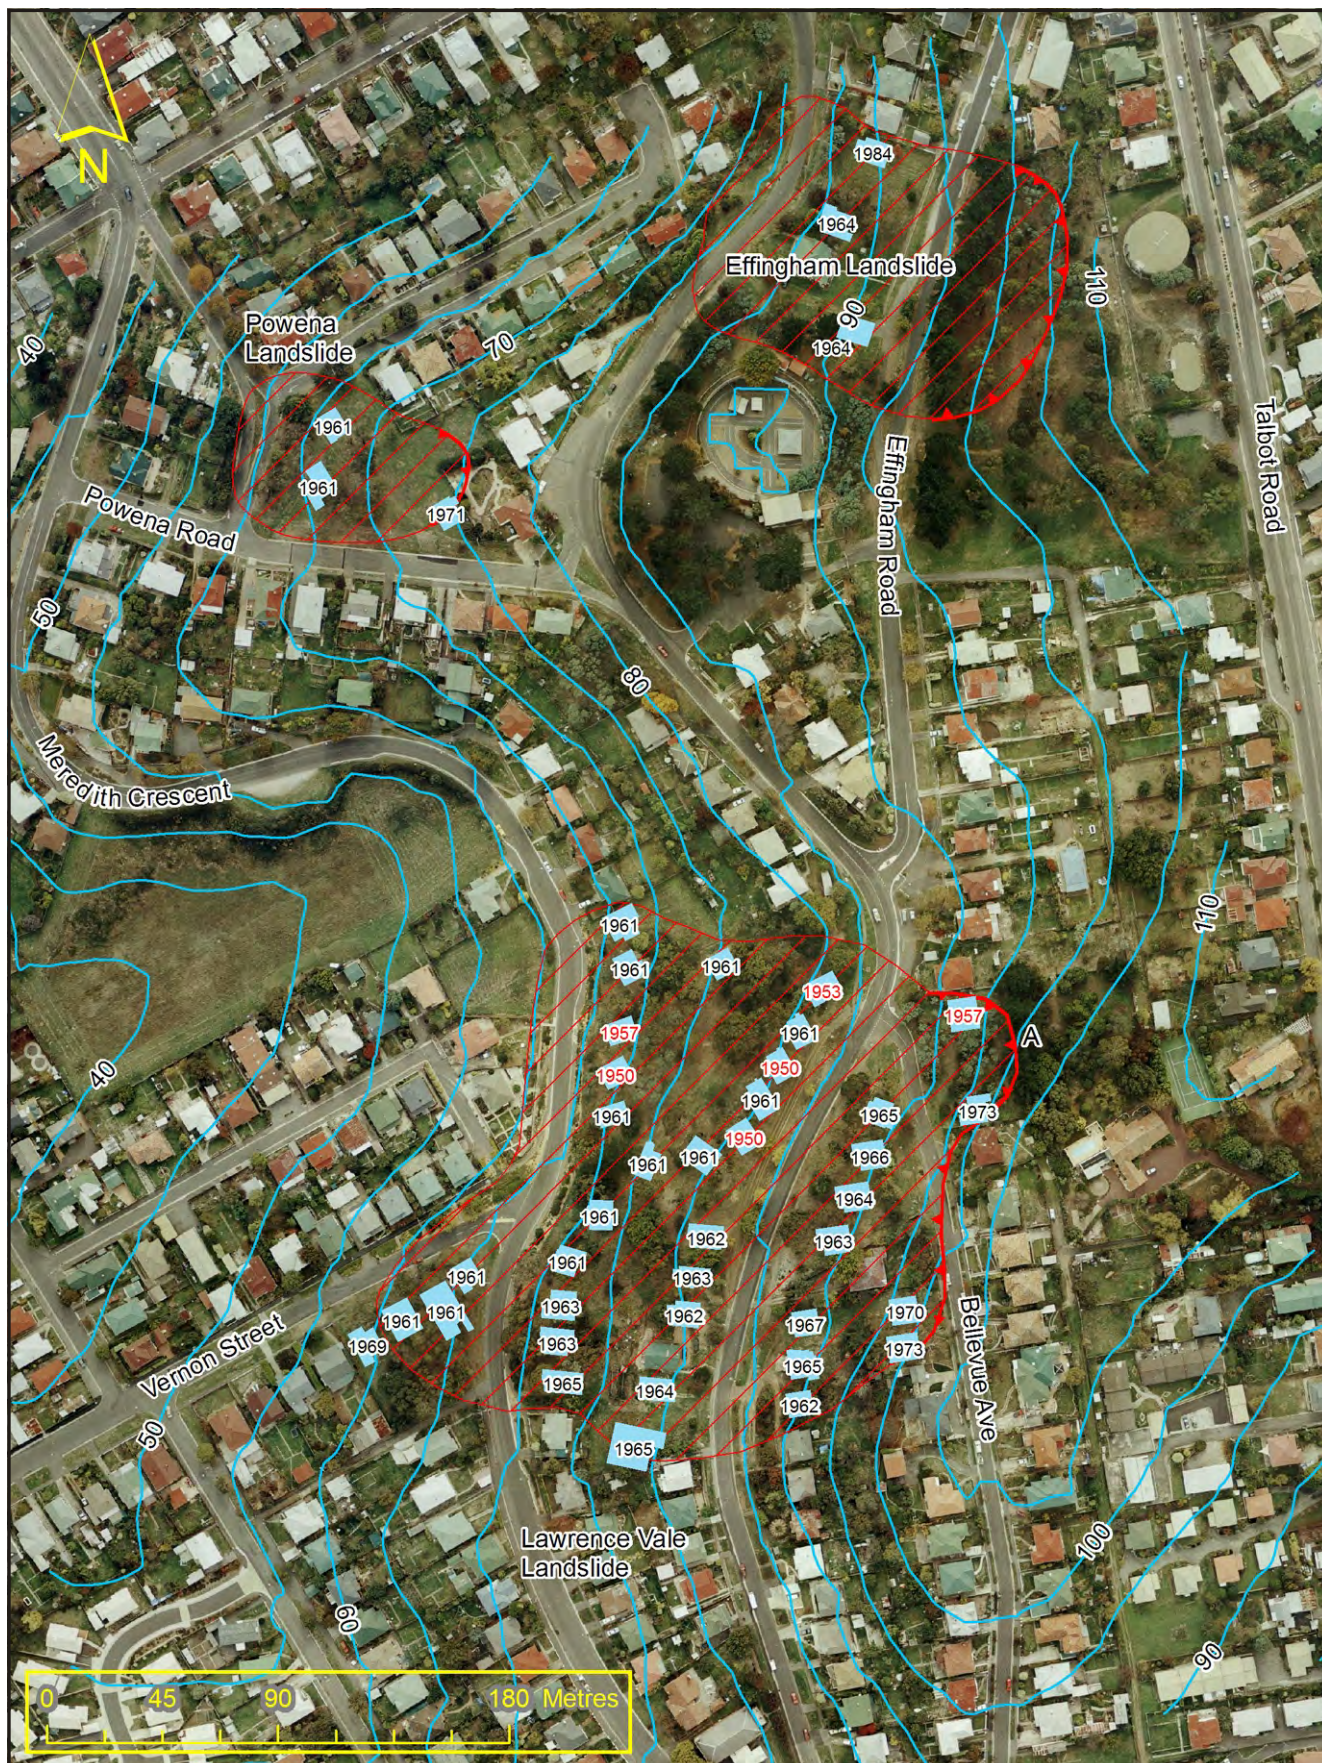
**Figure 3**

Map showing the Lawrence Vale area (informal name) including the three landslides under discussion (red hatching) with headscarps indicated by red ticks. Blue polygons indicate position of demolished houses; red labels indicates year of earliest known damage (from MRT records); black labels indicate year of proclamation under the Lawrence Vale Landslip Act when first damage date is unknown. Topographic contours are from Department of Primary Industries and Water. Orthophoto base (flown in 2003) is the property of MRT.

Total distance of movement for the three landslides cannot be precisely determined. In the case of the Lawrence Vale Landslide, the size of the head scarp and the toe mound suggests displacement in the order of 20 m or more. Total displacement on the other two landslides is probably much less based on surface morphology. On consideration of house damage details and previous monitoring results (fig. 3), the rate of movement is classified as Extremely Slow (<15 mm/year) using the Cruden and Varnes (1996) scale. While it is possible to build houses on Extremely Slow moving landslides (Cruden and Varnes 1996), the distribution of damage suggests that the landslide was not moving as a single rigid block. Rather, surface deformation such as warping and faulting has probably occurred over much of the area.

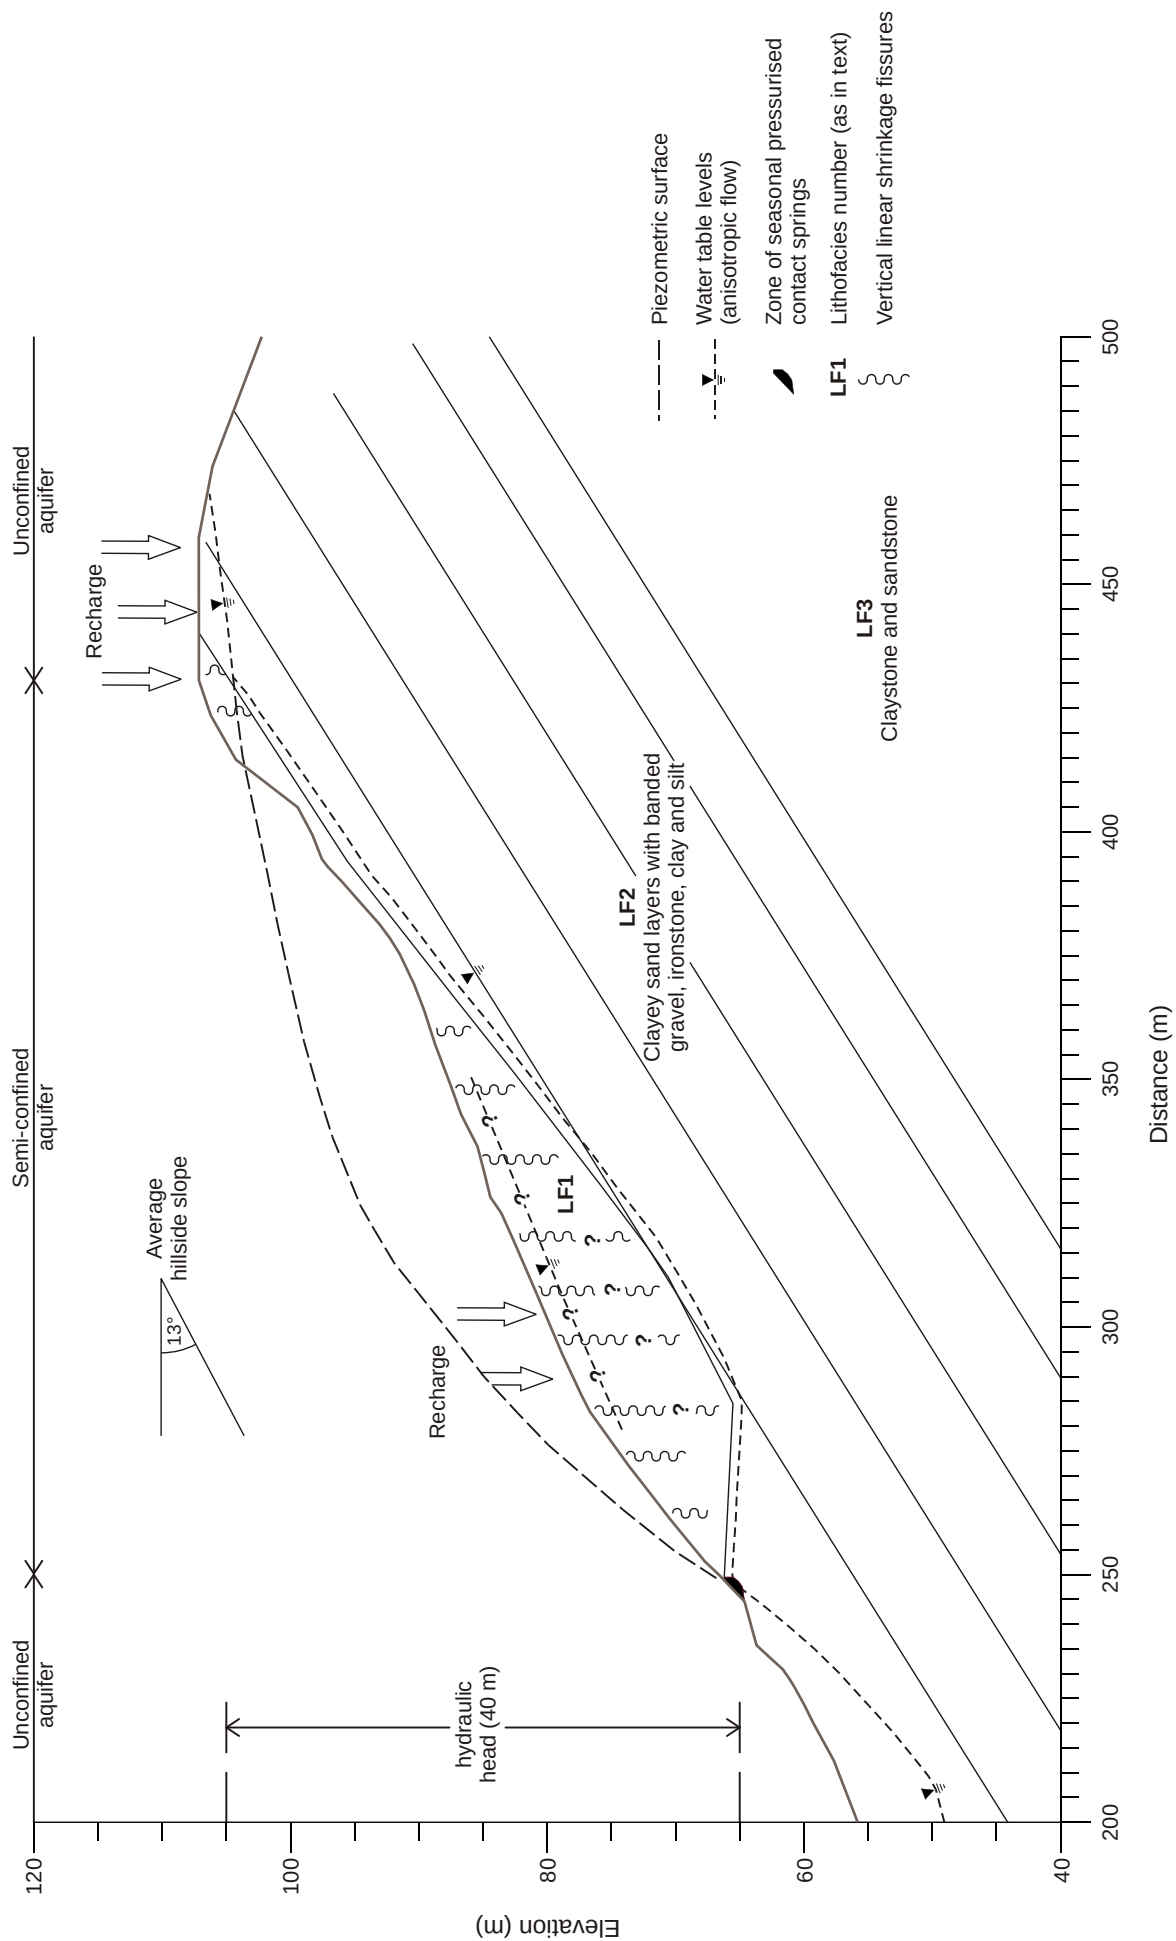
**Figure 13**  
*Hydrogeological conceptual model for the western side of Talbot Ridge.*

Time series data indicate that recharge on the ridge appears to occur where LF2 is exposed at the surface (as seen in the hydrograph of borehole CK\_BH14\_1977) and potentially via clay fissures in LF1 (as seen in the hydrograph of borehole CK\_BH16\_1977). As the hillside semi-confined aquifer is recharged, anisotropic flow rapidly increases the pore pressures within the aquifer (with a theoretical hydrostatic head of up to 40 m), perching water on the upper slopes of Talbot Ridge. During the winter months of 2005 the upper slopes of the Talbot Ridge aquifer remained perched, as seen in the hydrograph of borehole BM\_R4\_1996 (fig. 9). Recharge migrates downslope beneath LF1 to discharge from hillside springs topographically below LF1 or into the valley floor aquifer (LF6). This conceptual model is depicted in Figure 13.

the hillside slope, and the contrast in hydrological properties between LF1 and LF2, we have interpreted the failure surface to be situated approximately along this boundary over much of its length. With this geometry the three landslides would appear to be a combination of rotational and translational failure styles. Modelling of slope stability (Appendix 5) indicates that pressure changes in the LF1 fissured clay aquifer in the toe of the landslide are as important to landslide movement as LF2 pressure changes.

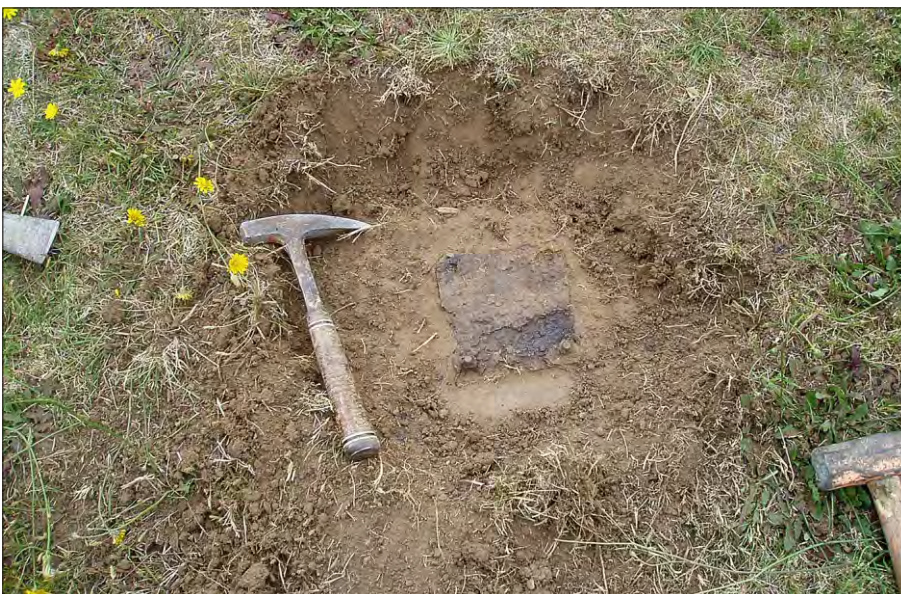
**Plate 2**

*Initial collar condition of bore hole 14 (Knights, 1977) January 2005.*

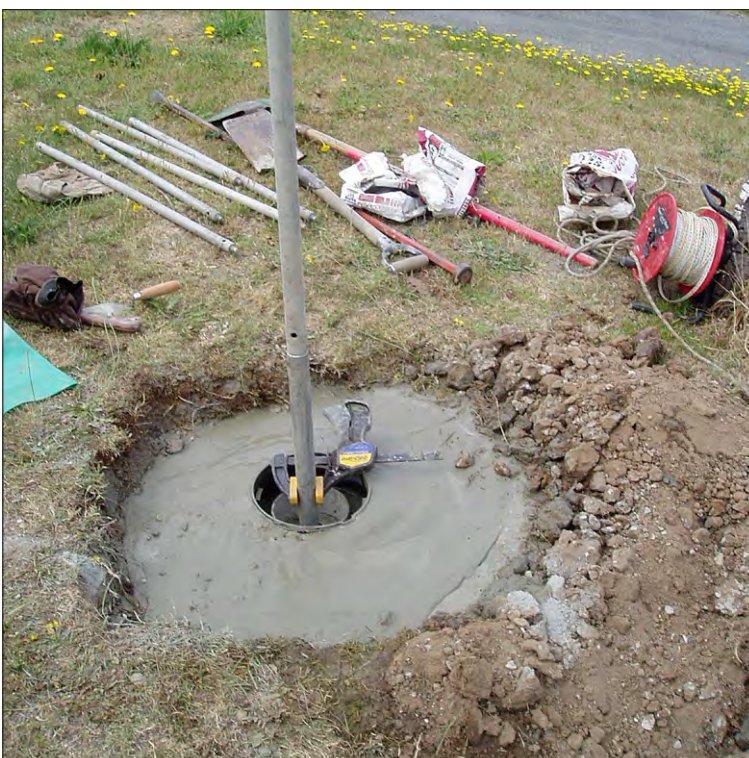
**Plate 3**

*Maintenance works being undertaken on bore hole 14 (Knights, 1977) during January 2005.*

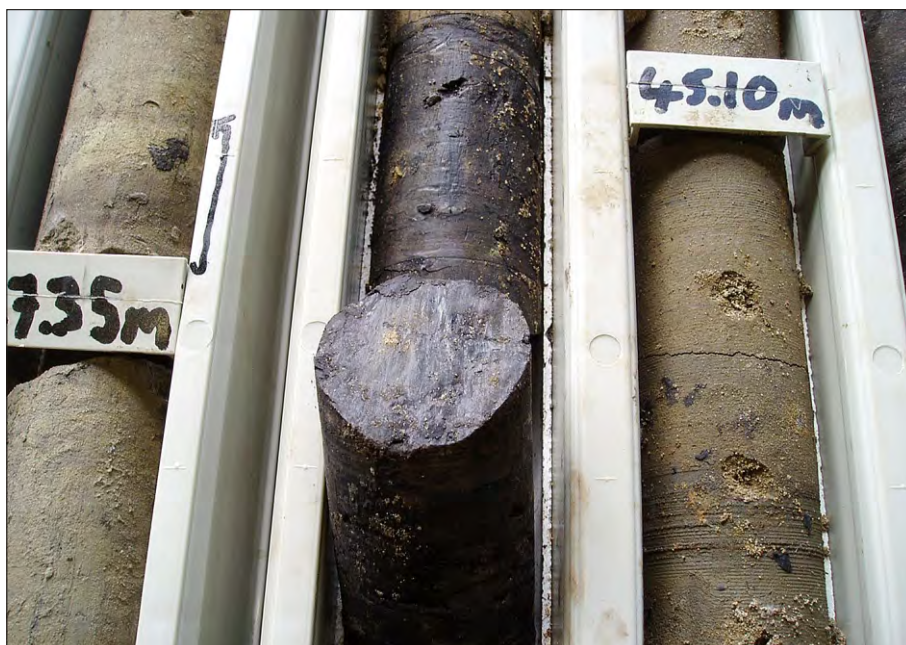
**Plate 8**

*Polished slickenside defect in coal  
at 46.50 metres in drill hole  
LV\_IBH1\_2005.*

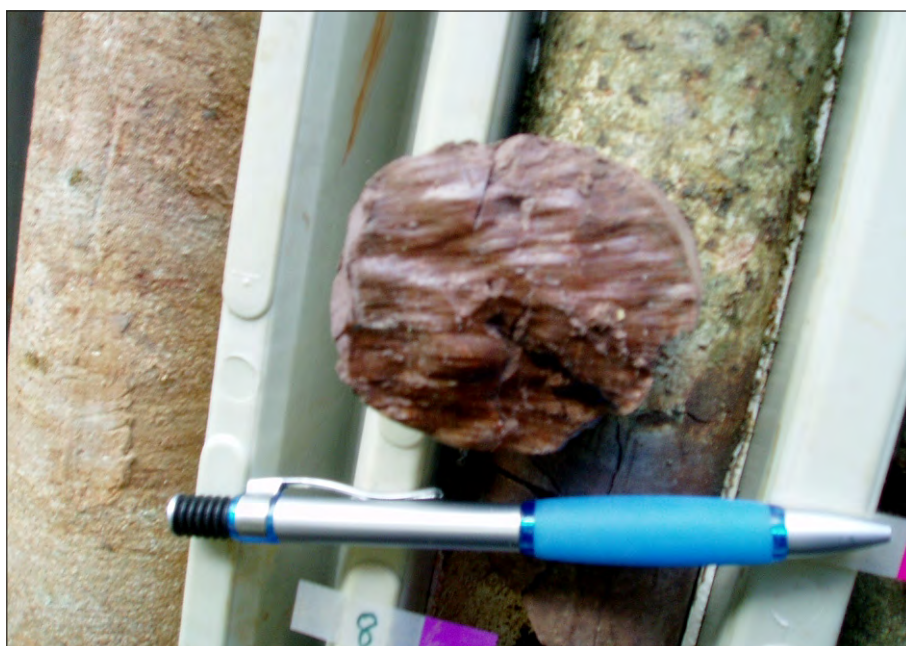
**Plate 9**

*Polished slickenside defect in  
claystone at 62.80 metres in  
drill hole LV\_IBH1\_2005.*
