## The effects of waste disposal on groundwater quality in Tasmania

### Chapel Street & Jackson Street waste depots, Glenorchy

Tasmanian Geological  
Survey Record 2002/11

# Groundwater quality investigations at the Chapel Street and Jackson Street waste depots, Glenorchy

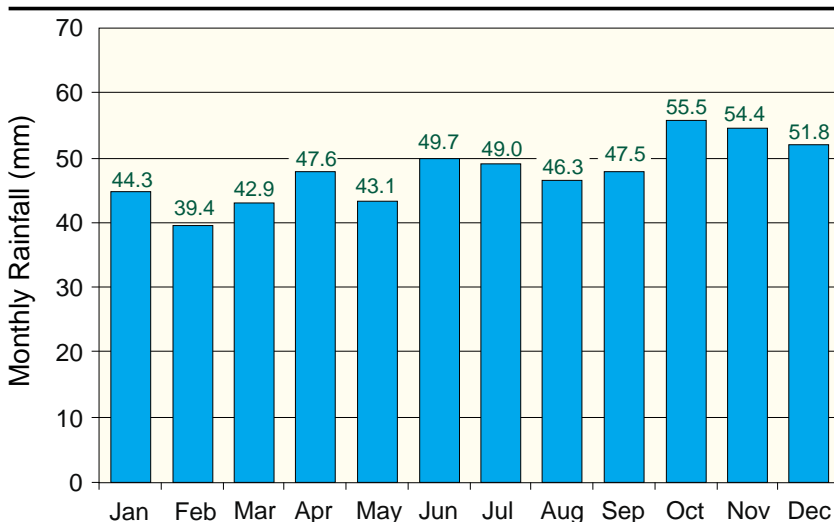
**Figure 3**  
Average monthly rainfall for Australian Bureau of Meteorology rainfall station 094030, Hobart Botanical Gardens.

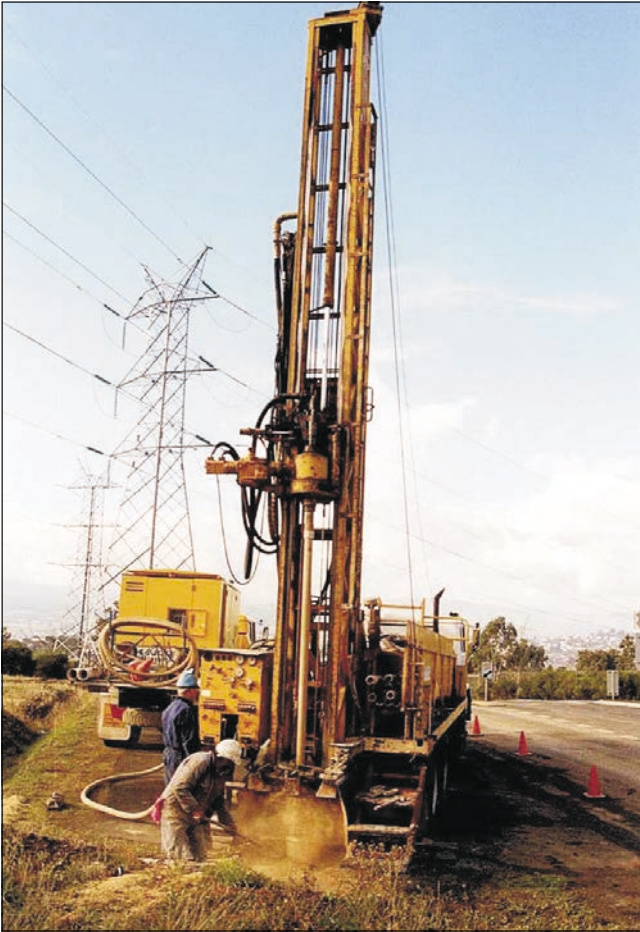
**Plate 2**

*Drilling bore hole JS2001/2 on 28 May 2001.*

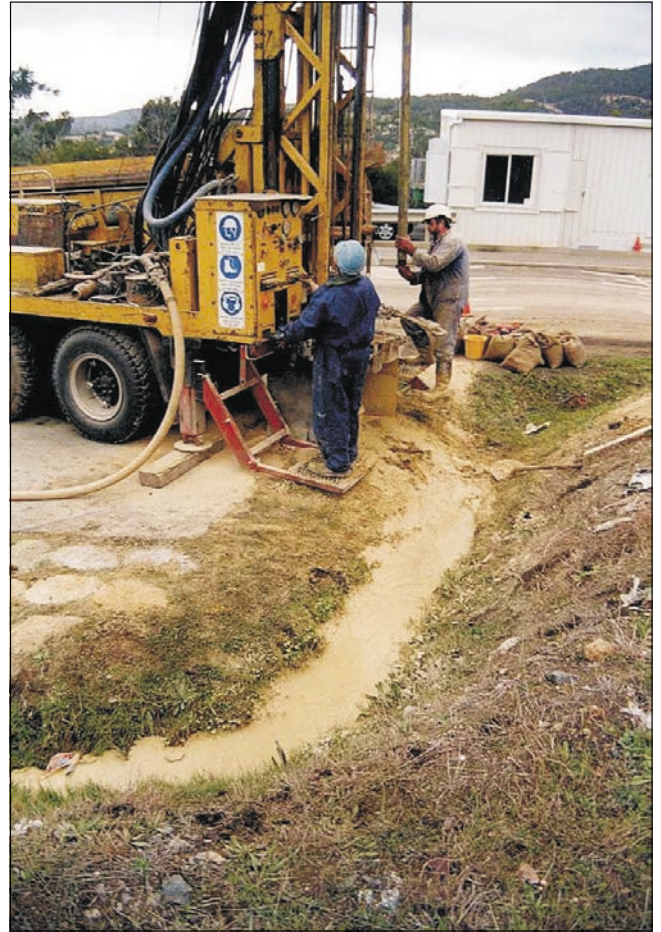
**Plate 3**

*Initial water strike during the drilling of bore hole JS2001/2 on 28 May 2001.*

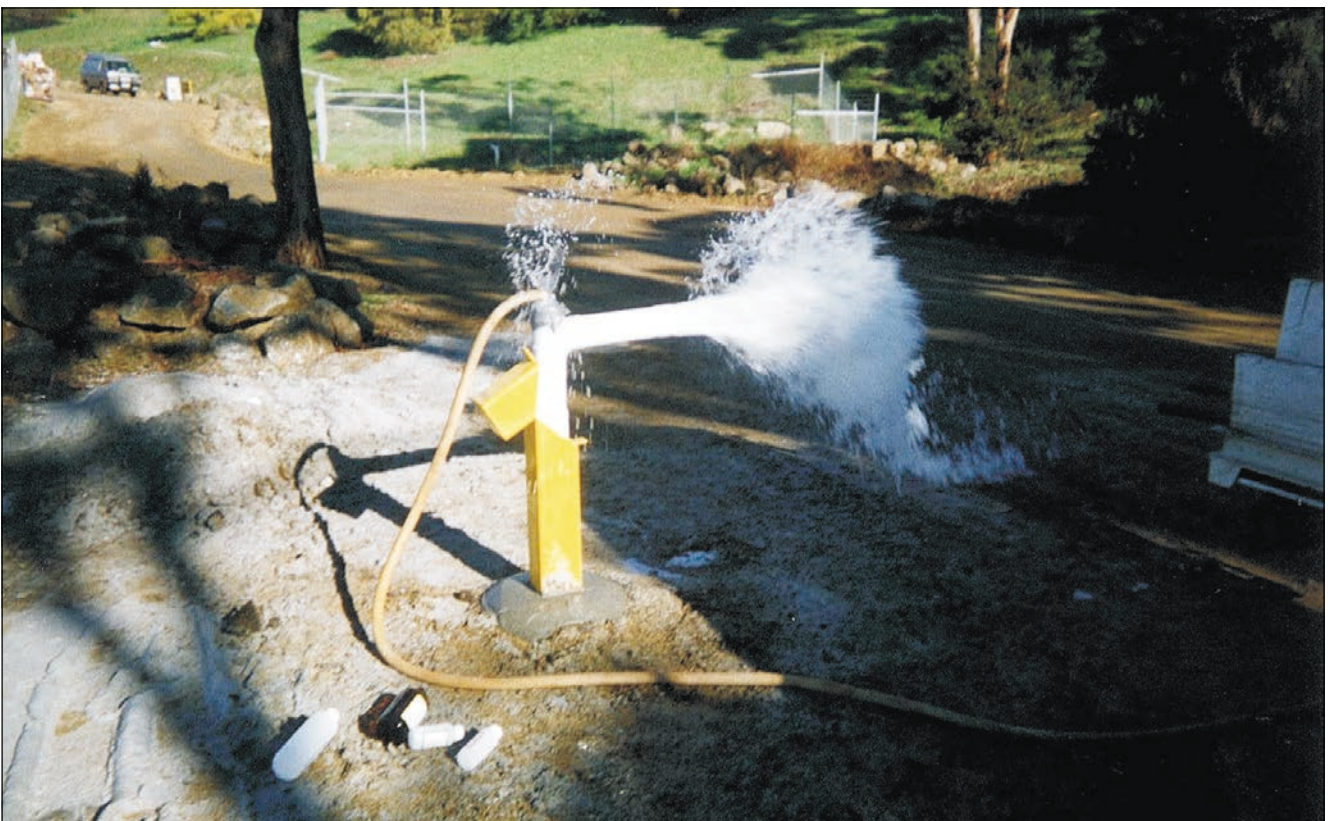
**Plate 4**

*Developing bore hole JS2001/1.*

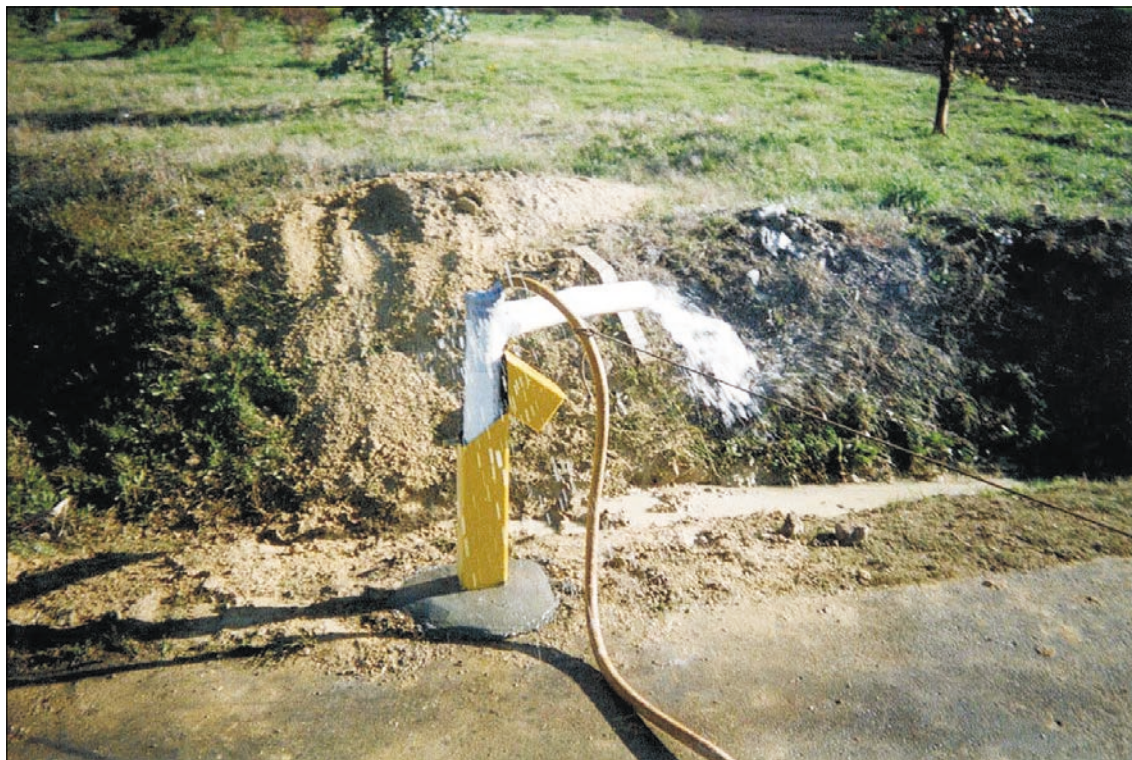
**Plate 5**  
*Developing bore hole JS2001/2.*

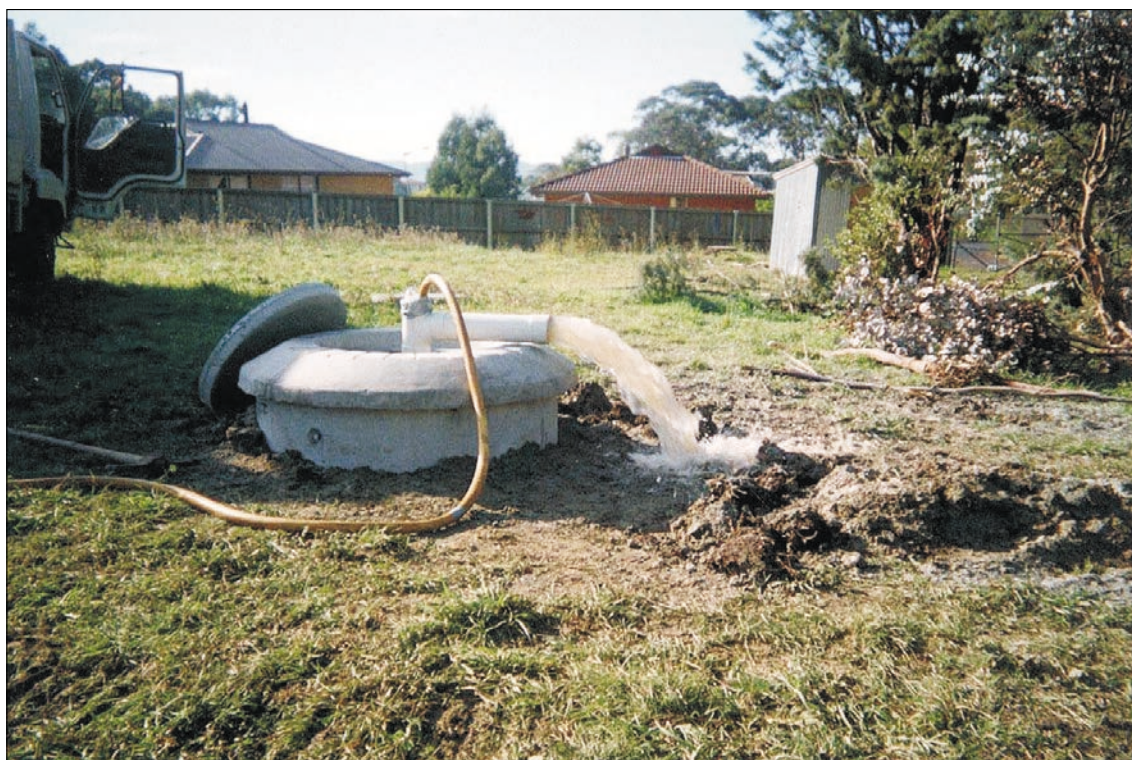
**Plate 6**  
*Developing bore hole CS2001/1. Note discolouration of water compared to Plates 4 and 5.*

Water within the fill, the leachate line and the leachate spring all had high conductivity, TDS, chloride, magnesium, sodium, iron and manganese concentrations. Groundwater sampled from CS2001/1 had a similar chemical signature, including total petroleum hydrocarbons. This implies the migration of leachate from the fill material into the Permian sedimentary aquifer down gradient of the landfill. The water strike one metre above the bedrock in CS2001/1 could indicate that migration is occurring in the base of the Quaternary alluvium as well as within the fractured aquifer system.

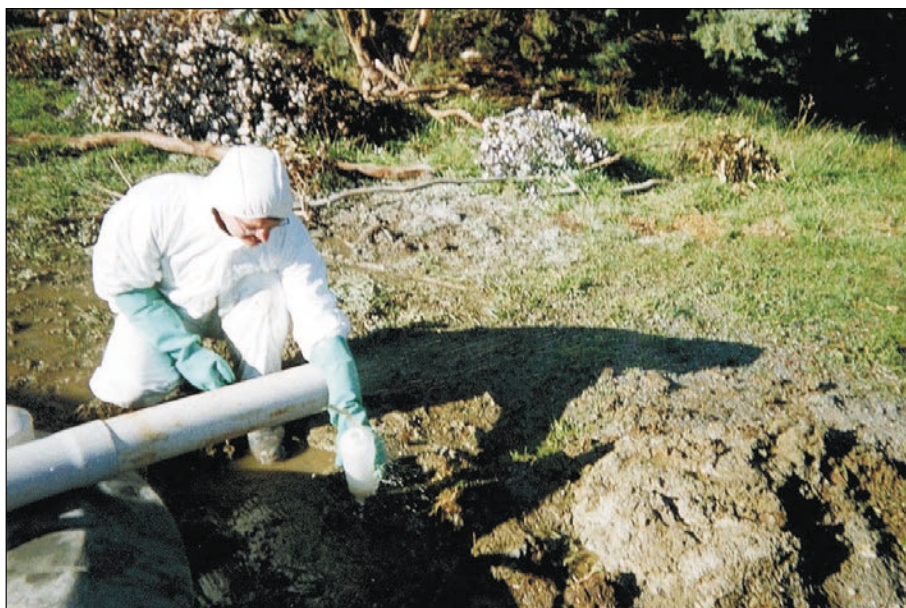
**Plate 7**

*Sampling bore hole CS2001/1 at the completion of developing the bore on 1 June 2001.*

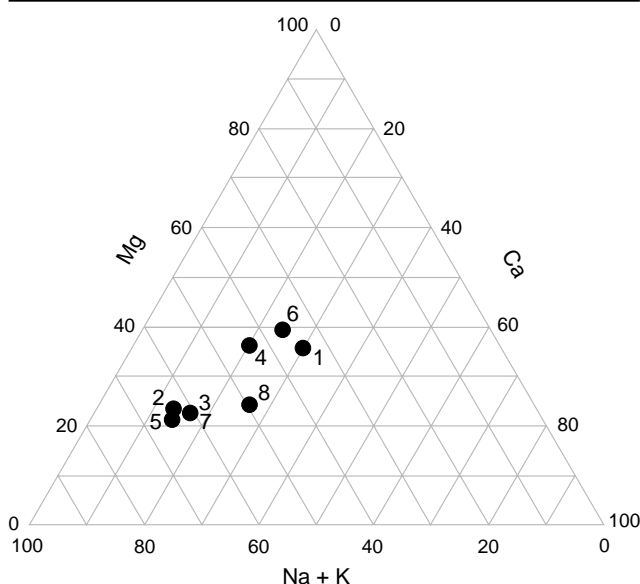
Figure 6

Cation Ternary plot for surface and groundwater samples at the Chapel Street waste depot.

- 1 - CS2001/1 (05/06/01); 2 - leachate line;
- 3 - leachate spring (05/06/01); 4 - CSTP2001/4;
- 5 - leachate spring (04/06/01); 6 - CS2001/1 (01/06/01); 7 - average of all MRT groundwater records for Permian sediments; 8 - average of all MRT groundwater records for Jurassic dolerite.

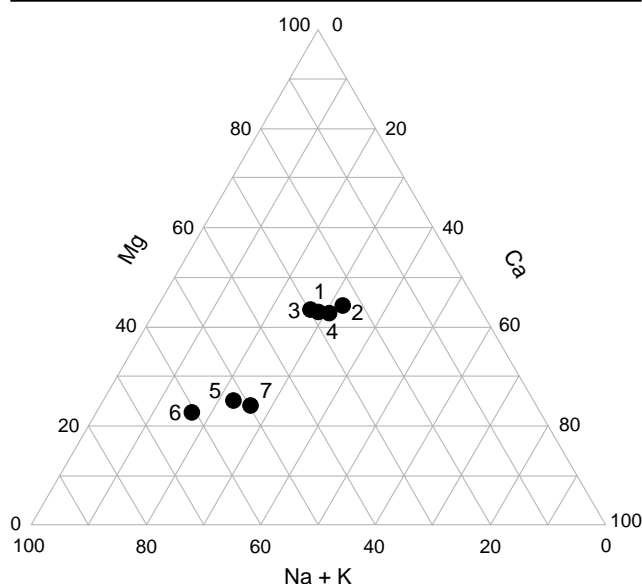
Figure 7

Cation Ternary plot for groundwater samples at the Jackson Street waste depot.

The Ternary plot (fig. 7) shows high magnesium concentrations for all bores at this landfill. This is considered an overprint of the natural dolerite groundwater signature (Ezzy, 1999). No target contamination indicators (e.g. chloride, ammonia and iron) were detected in the area of the Jackson Street landfill. It should be noted that a cluster of local bores (except JS2000/4) on the cation Ternary plot (fig. 7) is distinctly different to the statewide averages for these rock types. This may imply a natural geochemical groundwater signature, or a distinct change in the bedrock aquifer chemistry due to the migration of highly mobile ions from the fill. The total petroleum

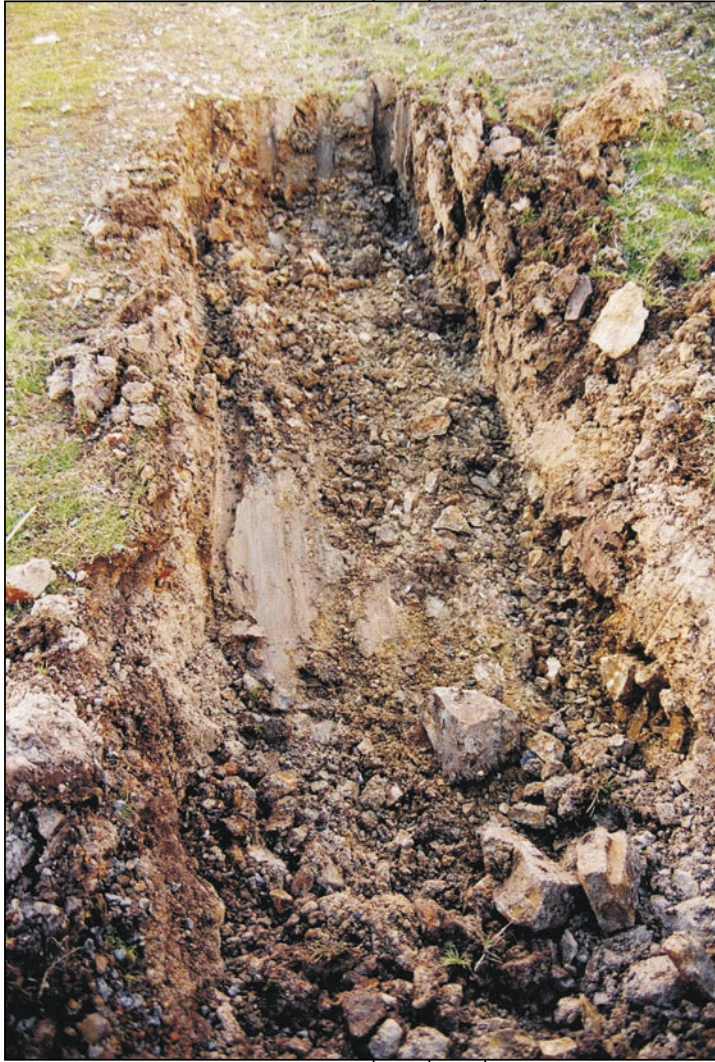
test pit no.	CSTP 2001/2
sheet	1 of 1

CH	CLAY - high plasticity, brown	D	St	Reworked weathered Permian rocks
				0.5			Refusal on grey mudstone at 0.35 m

# ENGINEERING LOG - TEST PIT

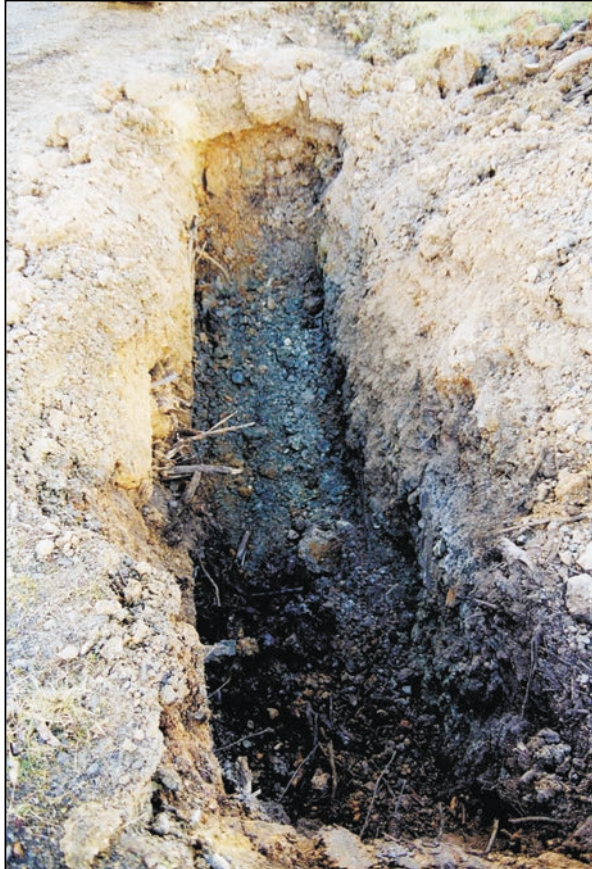
project	Chapel Street waste depot			location	Chapel Street, Glenorchy		
co-ordinates	55 520350 mE	equipment type	320B 20 tonne Excavator	pit commenced	28 May 2001		
	5256037 mN	bucket size	0.6m	pit completed	28 May 2001		
R.L.		width	0.6m	excavated by	Glenorchy City Council		
		length	3.3m	logged by	Mr Andrew Ezzy		
				checked by	Mr Adrian Waite

penetration	support	water	notes	metres	graphic log	classification	material	moisture	consistency	field records/comments
1 2 3			samples, tests	R.L. depth		symbol	soil type: plasticity or particle characteristics, colour, secondary and minor components.	condition	density index	insitu testing, soil structure, soil origin, additional observations
						CL	CLAY - medium plasticity, grey and brown, 10% dolerite cobbles	M	F	Road materials
			Minor (flow 0.005 l/s)	0.5						
				1.0						
				1.5			Refusal on grey mudstone at 1.5 m			Flow of water across bedrock surface at base of unconsolidated material
			Main (flow 0.036 l/s)

Groundwater was encountered in test pit CSTP2001/1 at 0.5 and 1.5 m, with flows of 0.005 and 0.036 l/s respectively. Groundwater was also encountered at 1.4 m within the waste fill material in test pit CSTP2001/4.

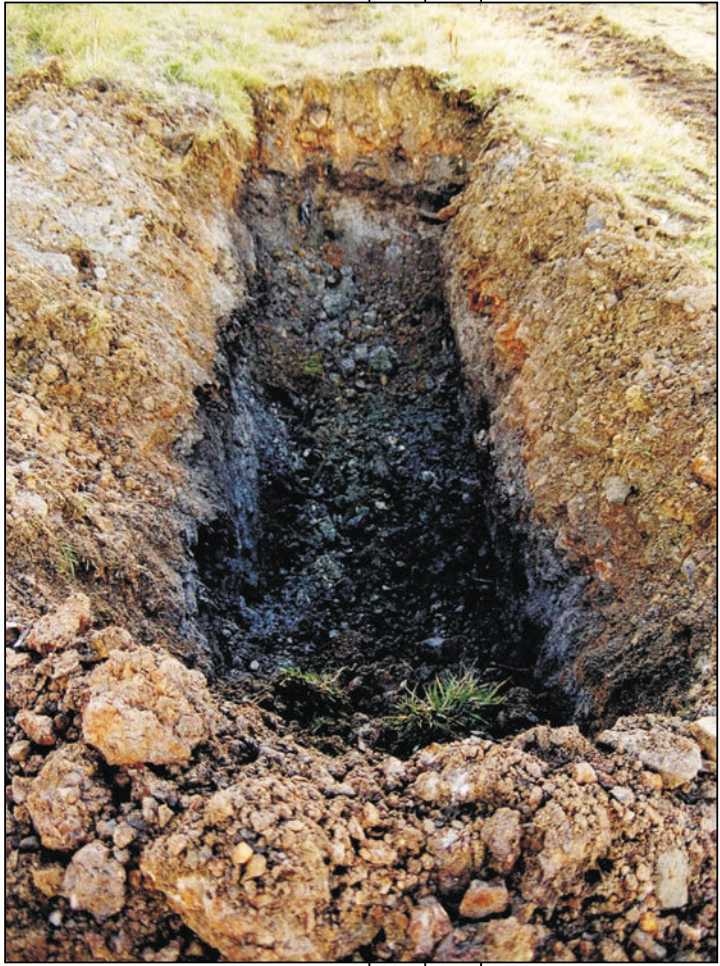
test pit no.  
**CSTP 2001/3**  
 sheet 1 of 1

penetration	support	water	notes	metres	graphic log	classification	material	moisture	consistency	field records/comments
1 2 3			samples, tests	R.L. depth		symbol	soil type: plasticity or particle characteristics, colour, secondary and minor components.	condition	density index	insitu testing, soil structure, soil origin, additional observations
							MUDSTONE - grey	D		Road base
				0.5		CH	CLAY - high plasticity, dark grey	M	F	Reworked weathered Permian rocks

1.0			Refusal on grey mudstone at 1.1 m

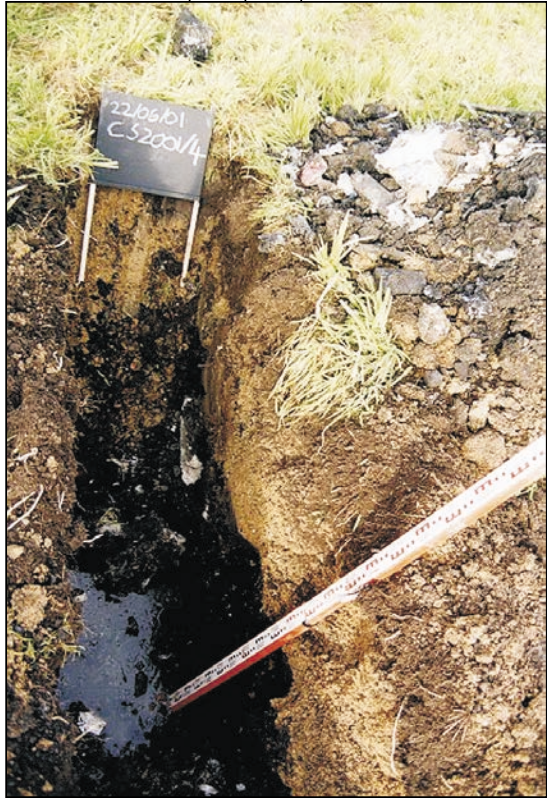
test pit no.  
**CSTP 2001/4**  
 sheet 1 of 1

WASTE fill - domestic refuse	W		
							Water sampled and analysed for metals, nutrients, total petroleum hydrocarbons and other general parameters End of hole in WASTE fill at 1.5 m

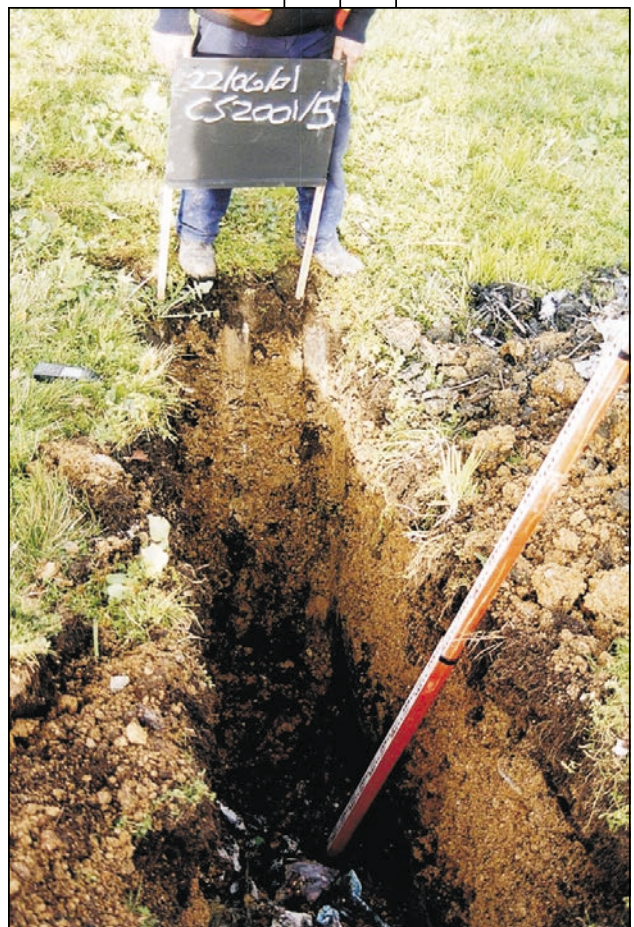
test pit no.	CSTP 2001/5
sheet	1 of 1

penetration	support	water	notes	metres	graphic log	classification	material	moisture	consistency	field records/comments
1 2 3			samples, tests	R.L. depth		symbol	soil type: plasticity or particle characteristics, colour, secondary and minor components.	condition	density index	insitu testing, soil structure, soil origin, additional observations
						OH	CLAY - black, humic	M	L	Soil cover
				0.5		CL	CLAY - medium plasticity, light brown, sedimentary rock fragments up to 7 mm	M	F	Main landfill capping cover
						CH	CLAY - high plasticity, green	M	F	
				1.0			WASTE fill- domestic refuse	W		Pit venting large volumes of landfill gas

End of hole in WASTE fill at 1.3 m

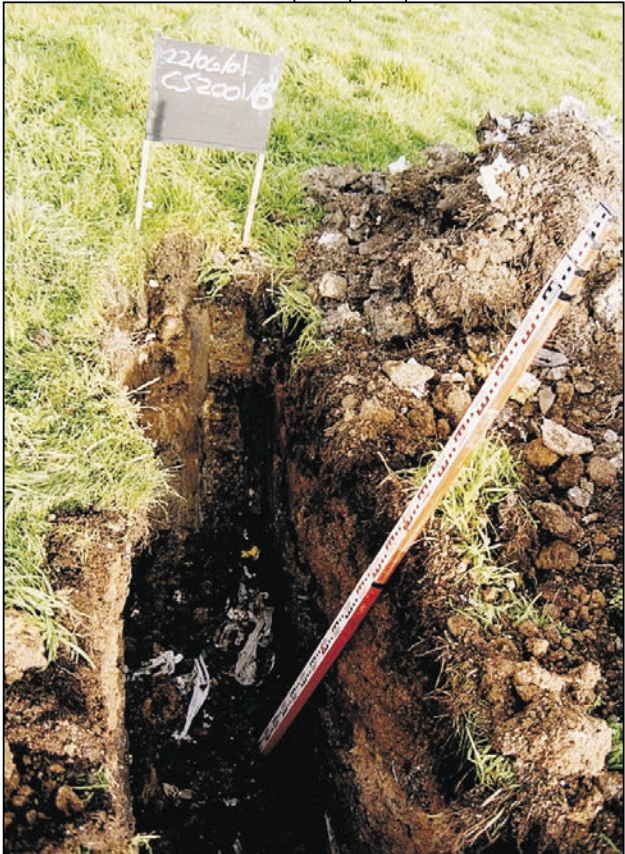
test pit no.  
**CSTP 2001/6**  
 sheet 1 of 1

WASTE fill - domestic refuse	D		Pit venting large volumes of landfill gas
				1.5			End of hole in WASTE fill at 1.5 m

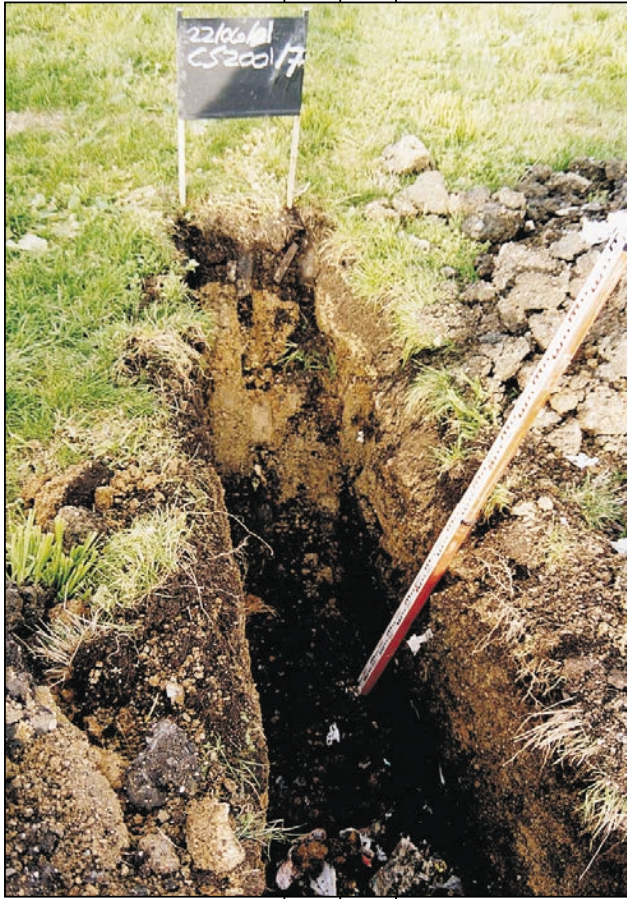
test pit no.  
**CSTP 2001/7**  
 sheet 1 of 1

project	Chapel Street waste depot			location	Chapel Street, Glenorchy		
co-ordinates	55 520064 mE	equipment type	320B 20 tonne Excavator	pit commenced	22 June2001		
	5256016 mN	bucket size	0.6m	pit completed	22 June2001		
R.L.		width	0.6m	excavated by	Glenorchy City Council		
		length	3.7m	logged by	Mr Andrew Ezzy		
				checked by	Mr Adrian Waite

penetration	support	water	notes	metres	graphic log	classification	material	moisture	consistency	field records/comments
1 2 3			samples, tests	R.L. depth		symbol	soil type: plasticity or particle characteristics, colour, secondary and minor components.	condition	density index	insitu testing, soil structure, soil origin, additional observations
						OH	CLAY - black humic	M	L	Soil cover
				0.5		CL	CLAY - medium plasticity, light brown, sedimentary rock fragments up to 7 mm	M	F	Main landfill capping cover
				1.0		CH	CLAY - high plasticity, black	M	F	
							WASTE fill- domestic refuse	D		Pit venting large volumes of landfill gas
							End of hole in WASTE fill at 1.3 m

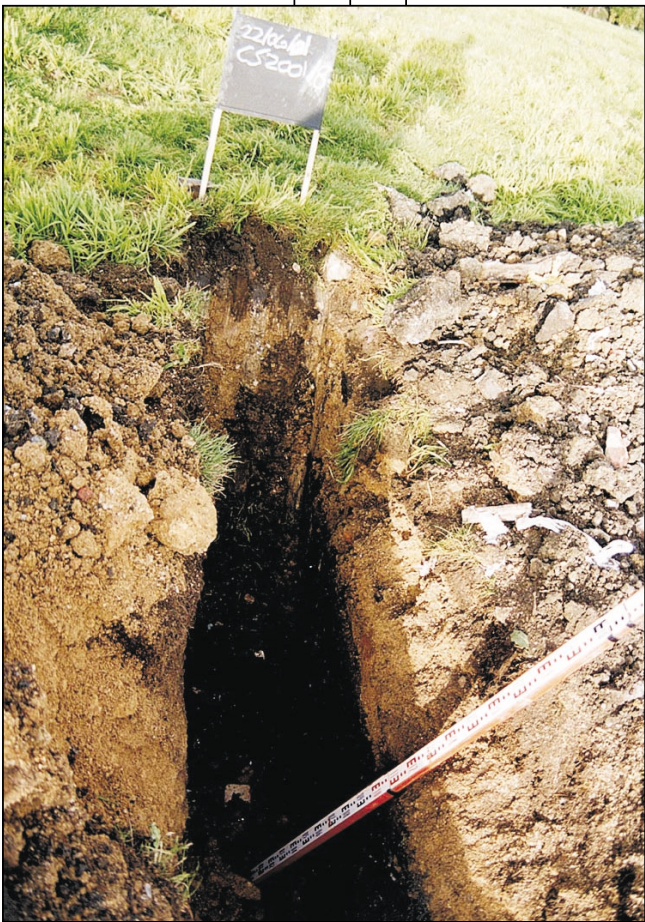
test pit no. **CSTP 2001/8**  
sheet 1 of 1

penetration	support	water	notes	metres	graphic log	classification	material	moisture	consistency	field records/comments
1 2 3			samples, tests	R.L. depth		symbol	soil type: plasticity or particle characteristics, colour, secondary and minor components.	condition	density index	insitu testing, soil structure, soil origin, additional observations
						OH	CLAY - black humic	M	L	Soil cover
				0.5		CL	CLAY - medium plasticity, light brown, sedimentary rock fragments up to 7 mm	M	F	Main landfill capping cover
				1.0		CL	CLAY - low plasticity, black, dolerite fragments up to 12 mm	D	Vst	
							WASTE fill - domestic refuse, dark grey soil	D		Pit venting large volumes of landfill gas
							End of hole in WASTE fill at 1.3 m

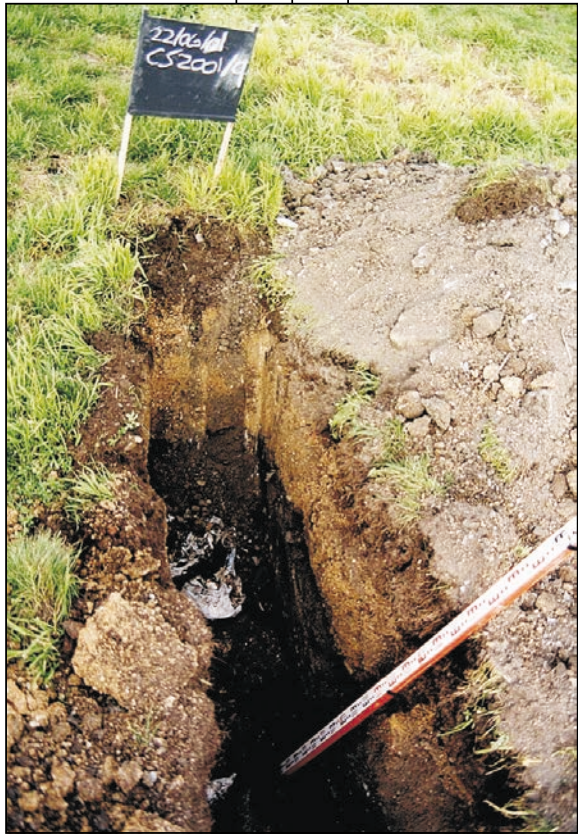
test pit no.  
**CSTP 2001/9**  
 sheet 1 of 1

WASTE fill- domestic refuse, dark grey soil	D		Pit venting large volumes of landfill gas
							End of hole in WASTE fill at 1.6 m
