**Tasmanian Geological Survey**  
**Record 2007/04**

# **Lawrence Vale Landslide Investigations: implications for landslide hazard assessment in Launceston**

*by A. R. Ezzy and C. Mazengarb*

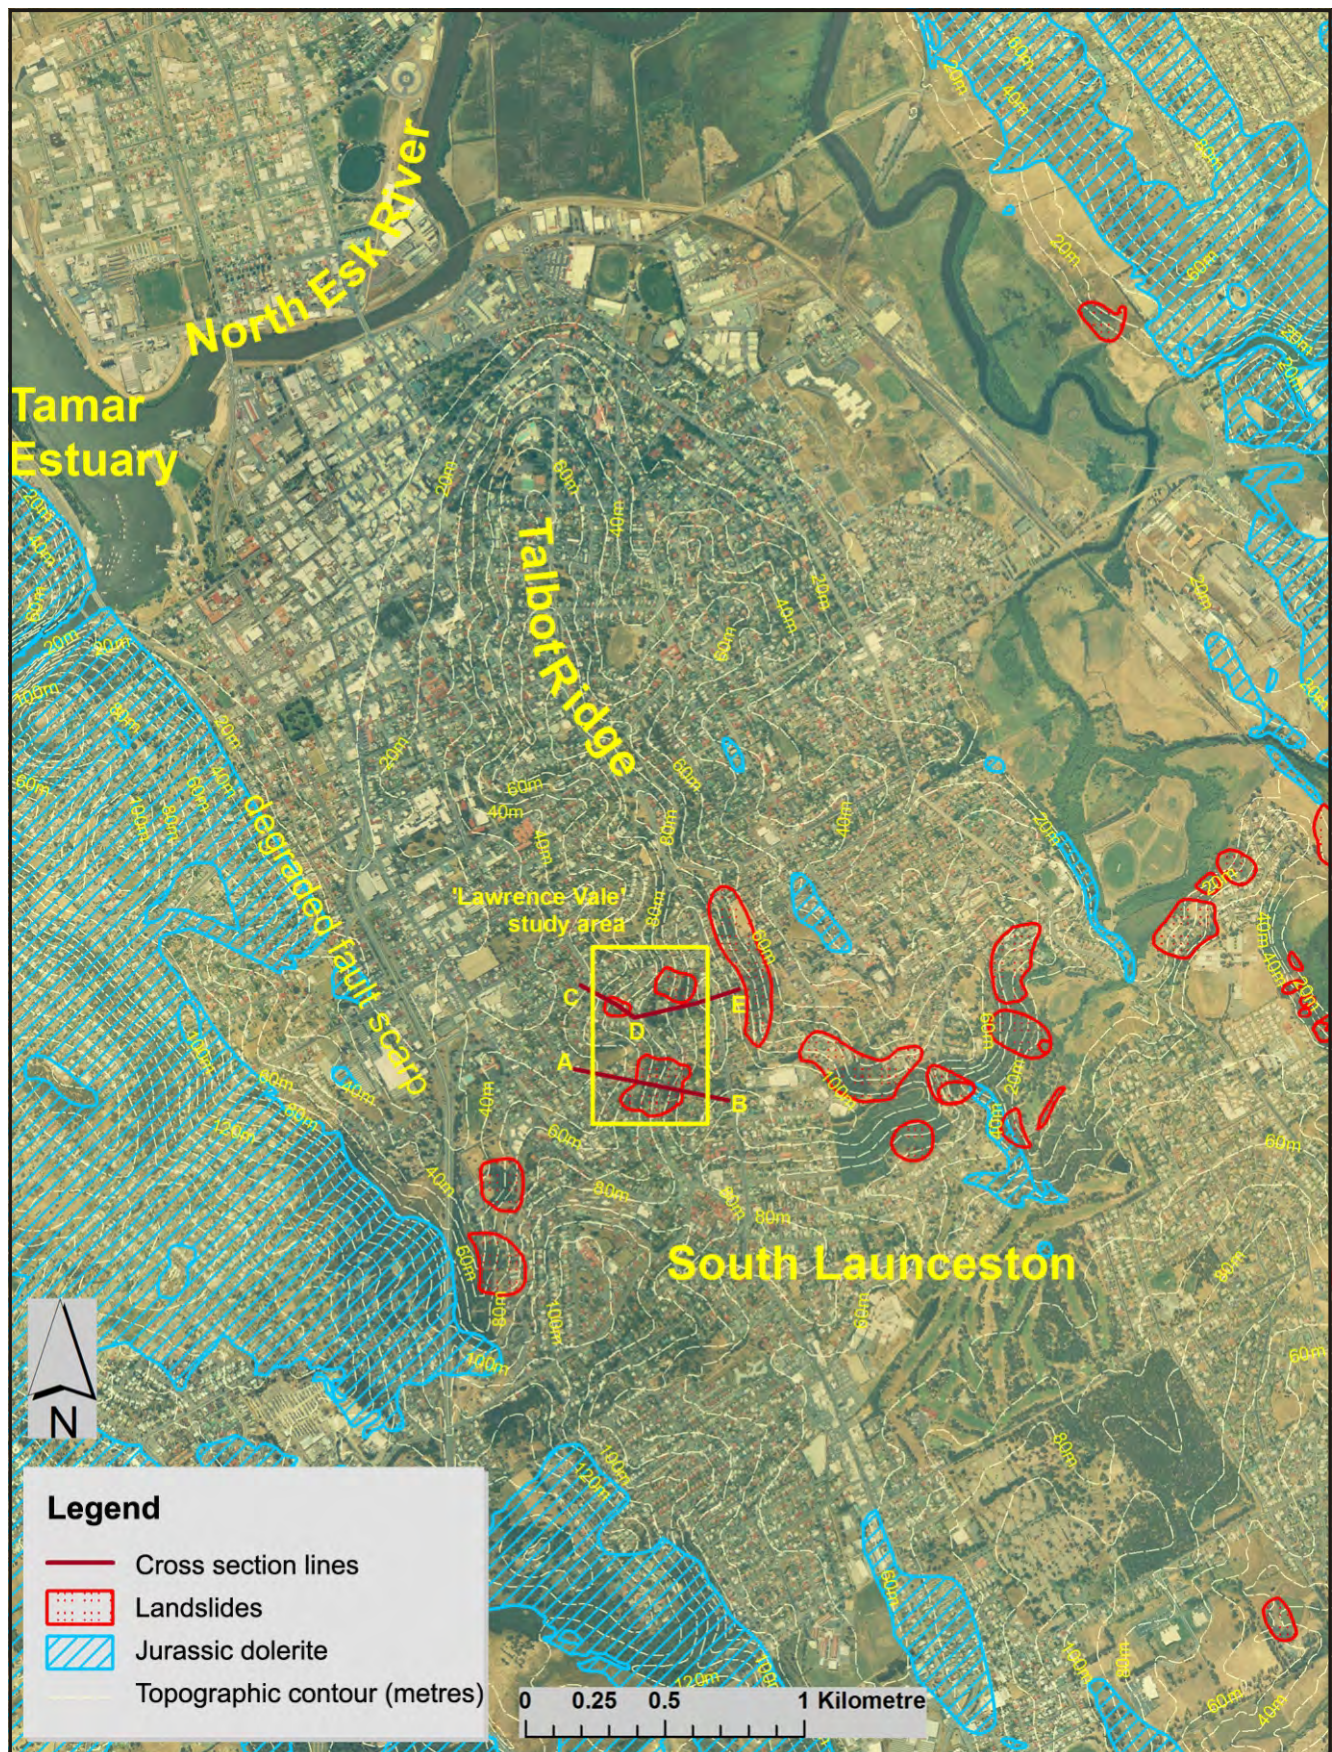
**Figure 2**

Talbot Ridge area and surrounds showing aspects of the geology and topography. Red polygons indicate position of landslides in MRT database. Yellow polygon indicates position of the three landslides under discussion including the Lawrence Vale Landslide. Orthophoto base from Department of Primary Industries and Water.

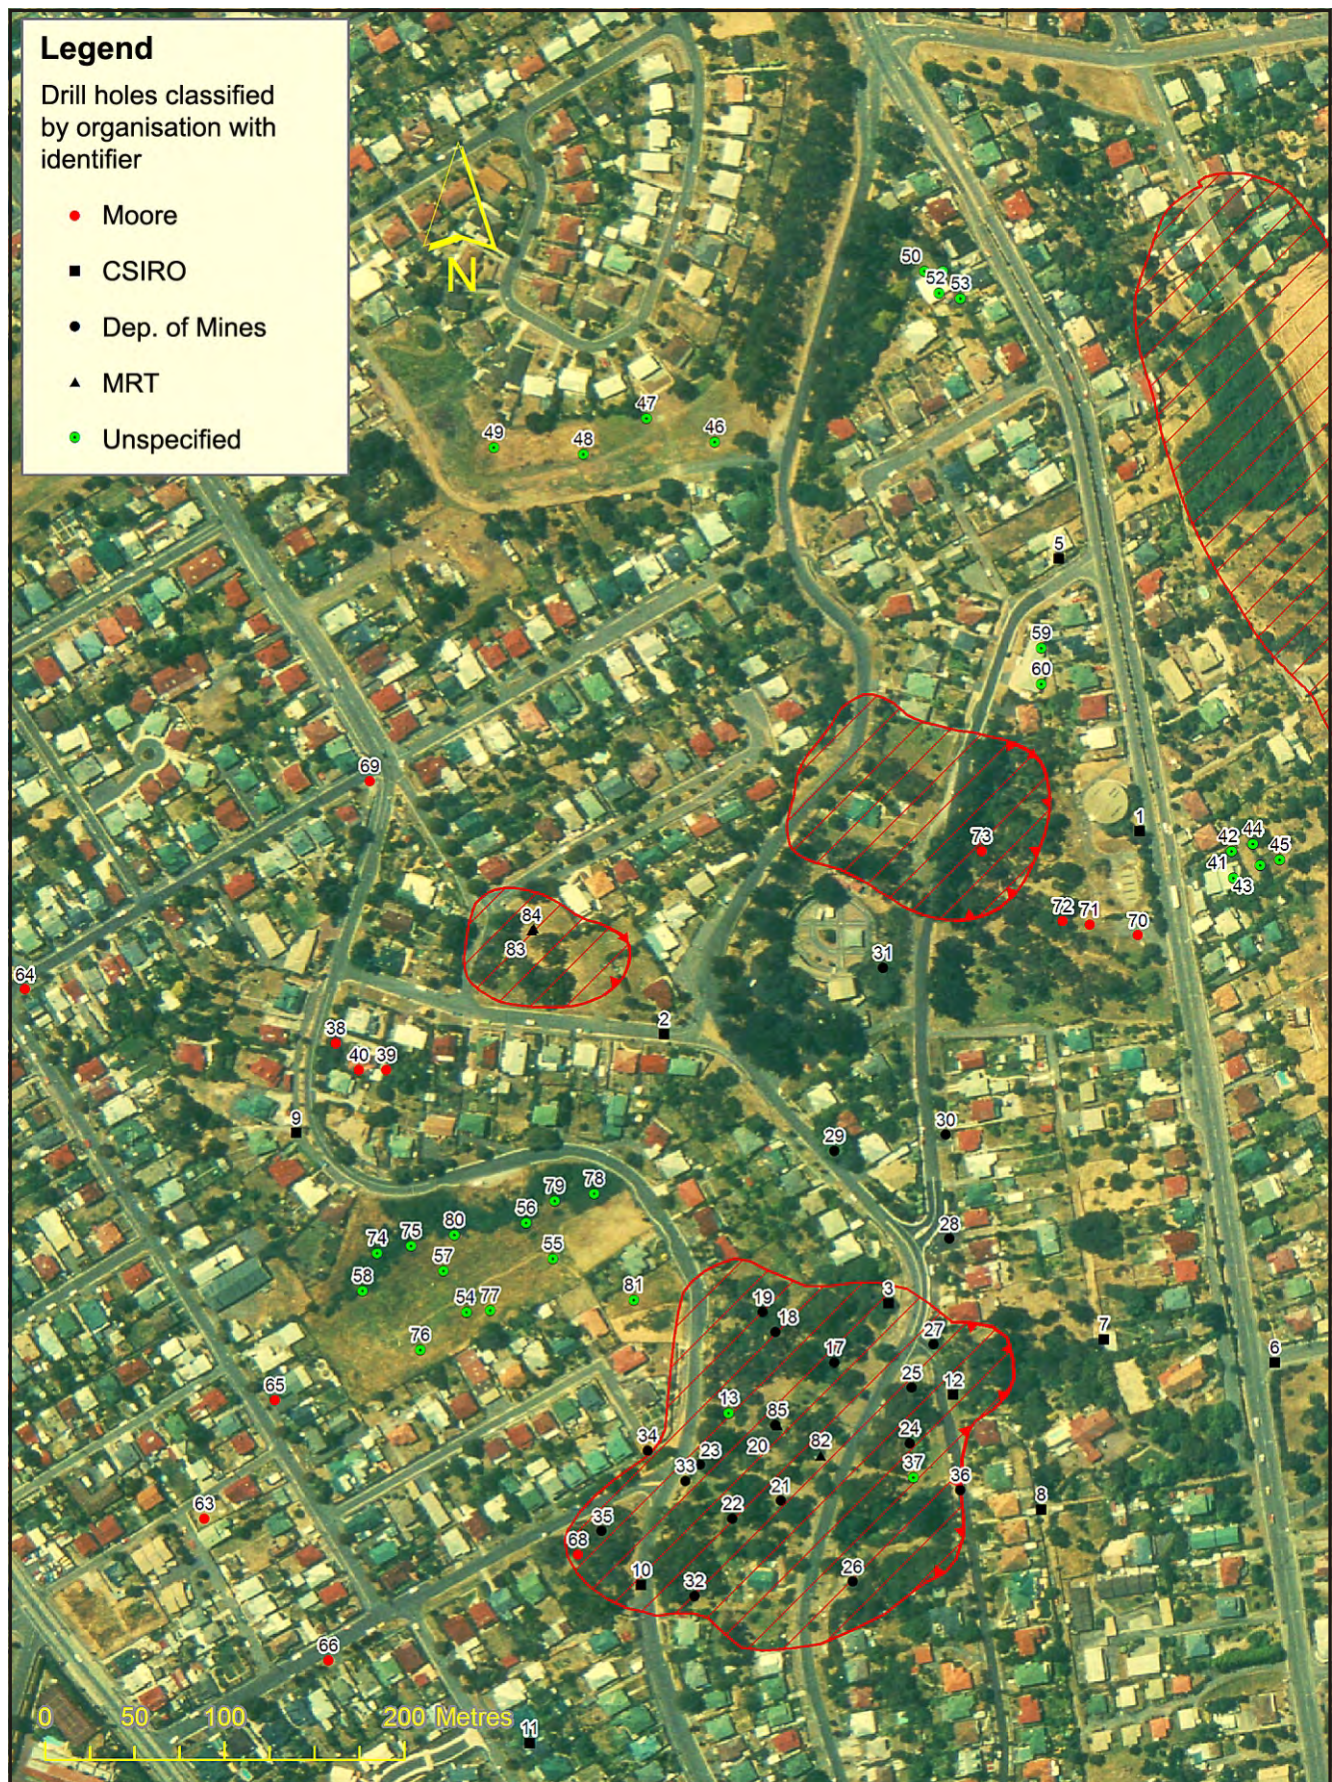
**Figure 5**

*Location of boreholes and test pits referred to in text. Details of these features are summarised in Tables 1 and 2.*

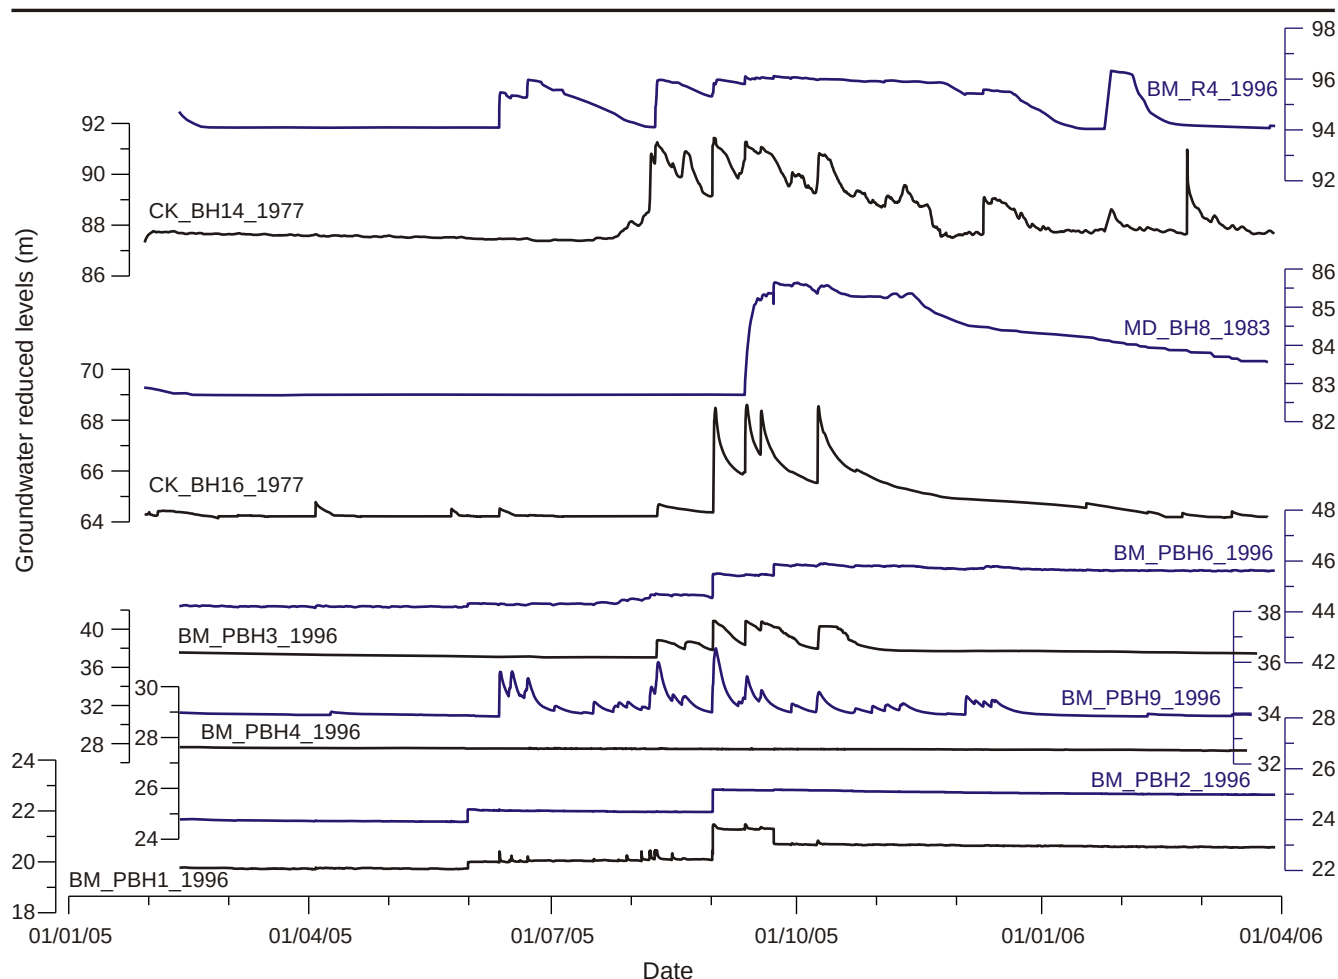
**Figure 9**

*Hydrographs of standing groundwater levels in the study area.*

monitoring interval, has been obtained from the Bureau of Meteorology to analyse the response of the piezometers to climatic events. Hydrographs of the piezometers are depicted in Figure 9 and many of them show convincing relationships to rainfall events (fig. 10). In particular, borehole CK\_BH14\_1977, above the Lawrence Vale Landslide and situated in the sand dominated unit (LF2), shows rapid response to rainfall events. A slug test in this hole indicated a hydraulic conductivity of  $10^{-2}$  m/d using the Bouwer and Rice

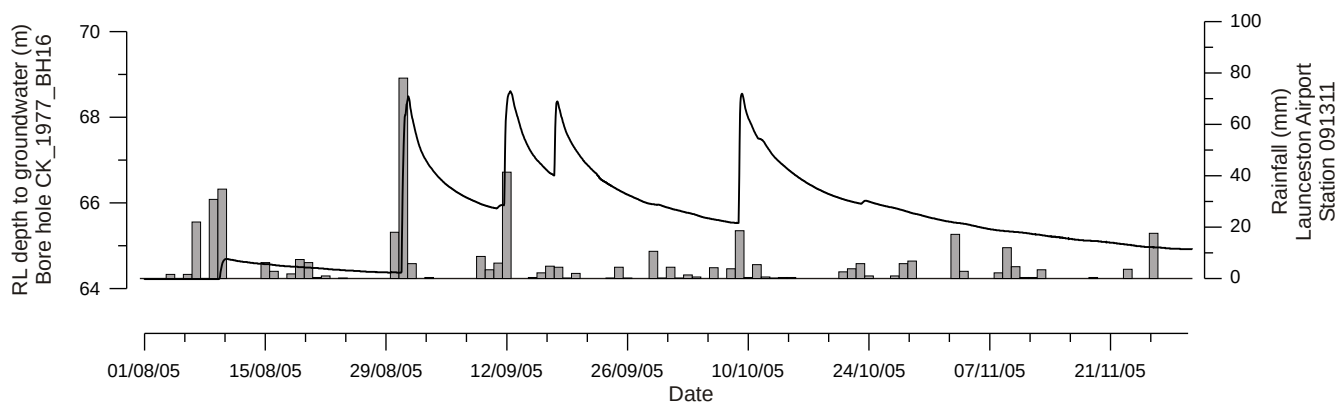
**Figure 10**

*Comparison of winter 2005 Launceston rainfall record to hydrograph of borehole CK\_BH16\_1977.*

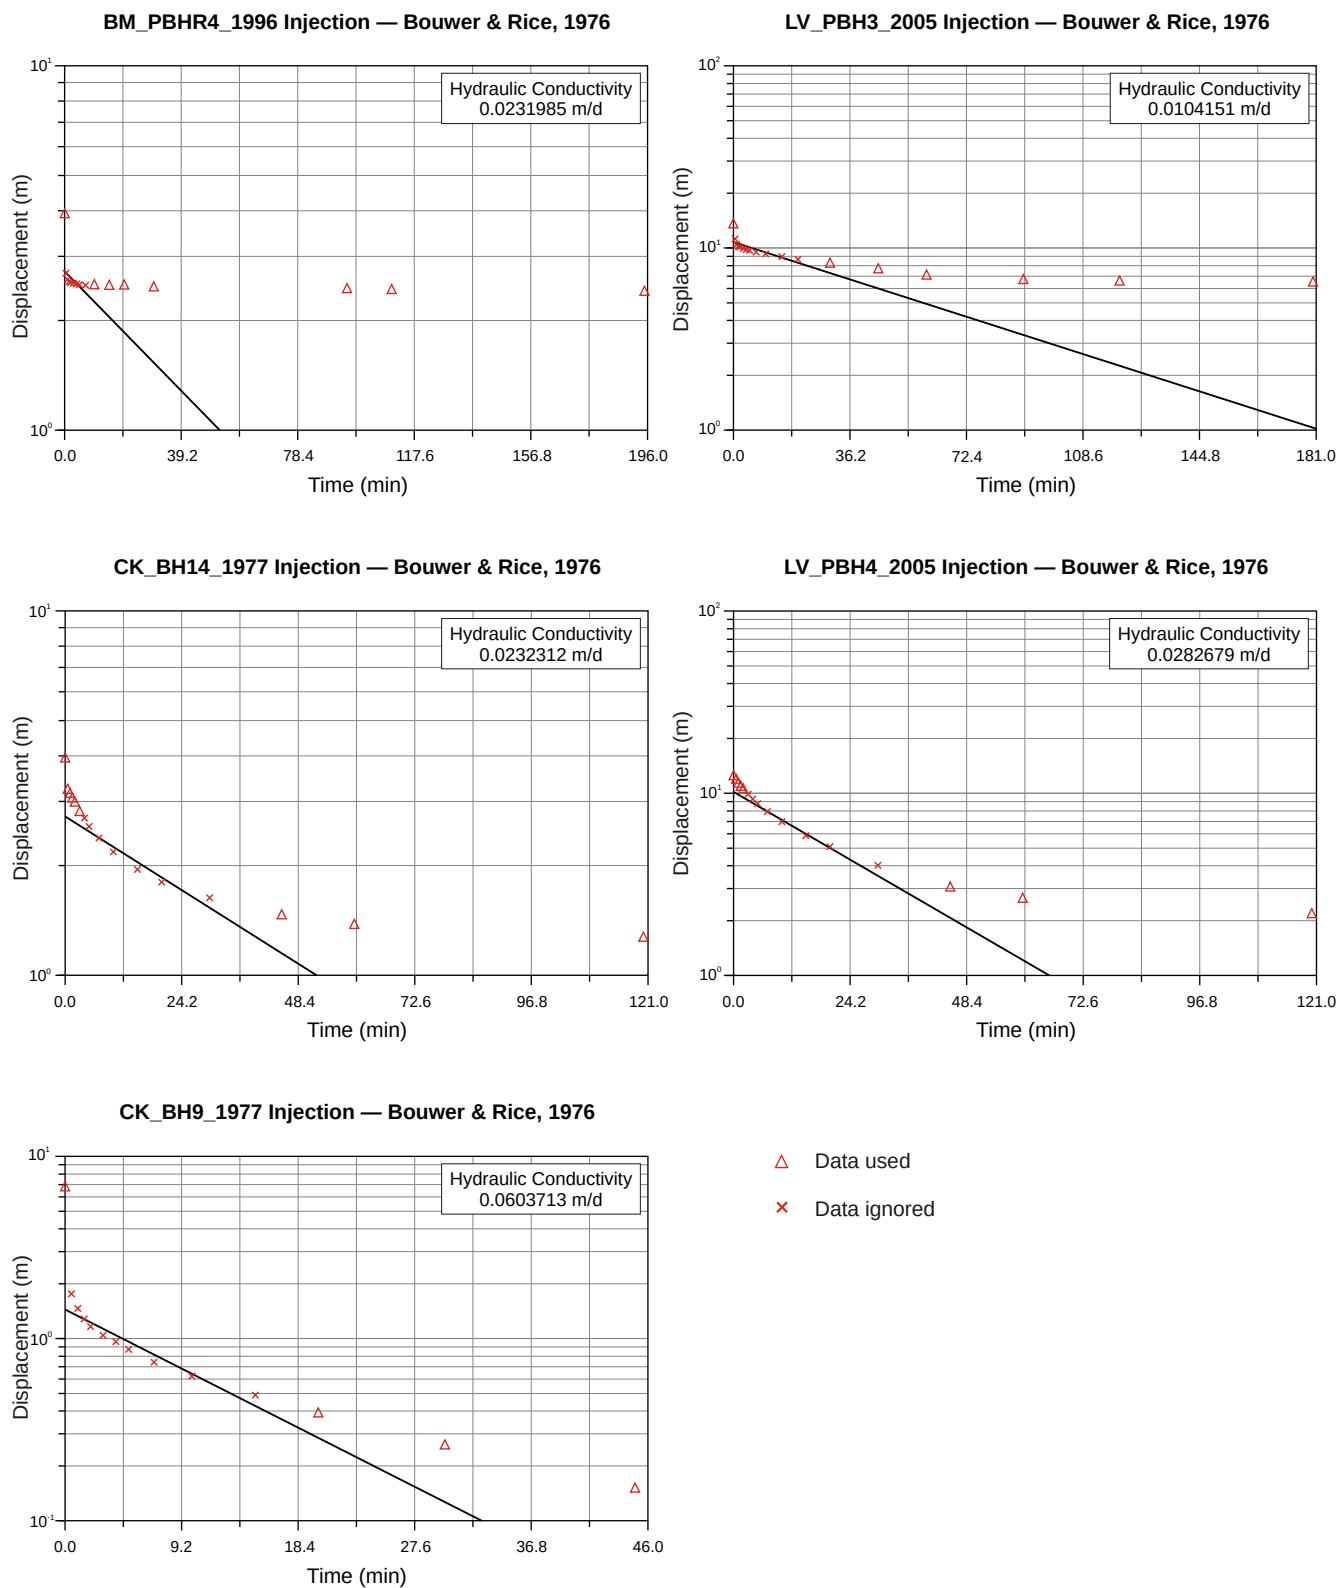
**Figure 11**  
*Solutions of in situ permeability tests and hydraulic conductivity values.*

(1976) method (fig. 11) and is consistent with theoretical values of this lithology. Figure 12 also indicates that all other slug tests undertaken produced the same order of hydraulic conductivity. Hydraulic conductivity was calculated on borehole CK\_BH16\_1977 for the falling head component of the base flow recession curve, i.e. the section following significant rainfall events (fig. 12). The result is two orders of magnitude less ( $10^{-4}$  m/d) than a slug test on the same bore ( $10^{-2}$  m/d). In short the aquifer at this location is quick to recharge but slow to drain.

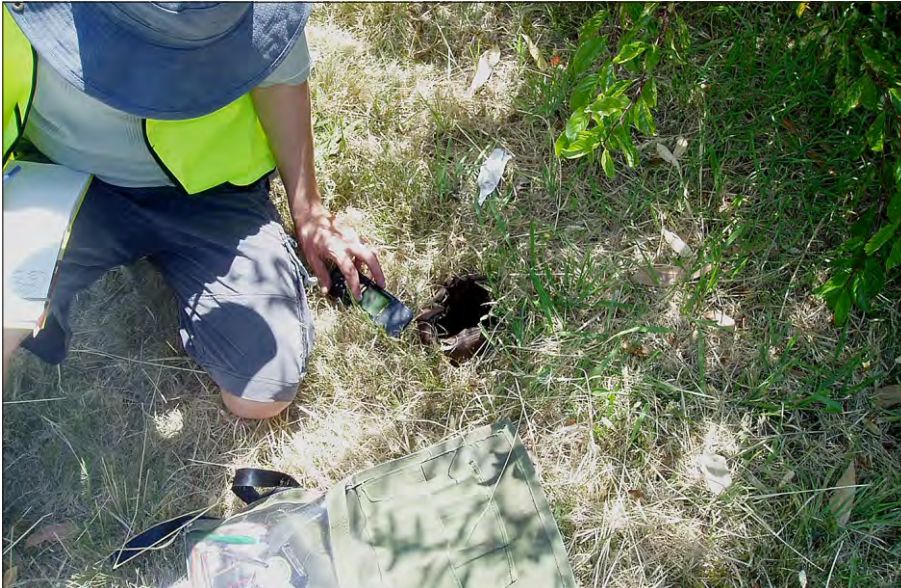
**Plate 1**

*Bore hole collar of DHH19 from 1959 CSIRO drilling program.*

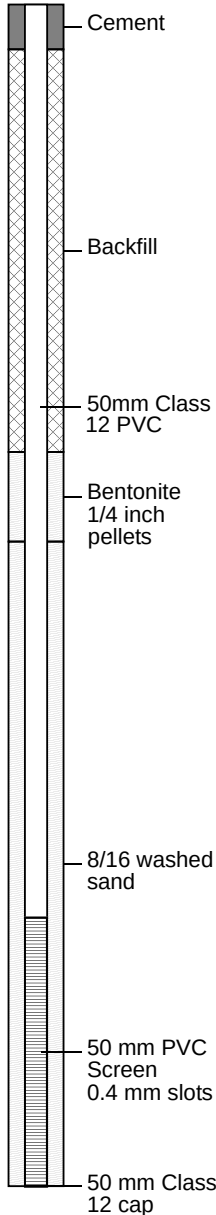
| MINERAL RESOURCES<br>TASMANIA<br><br><br><b>Tasmania</b><br>DEPARTMENT of<br>INFRASTRUCTURE,<br>ENERGY and RESOURCES | | | | ENGINEERING LOG - LV_PBH3_2005 (LV_ARE_2005_3) | | | | | |
|---|---|---|---|---|---|---|---|---|---|
| 0 | | | | Drilling log as LV_ARE_2005_2. | | | | | Solid stem auger drilling, 0 to 13.5 m. No samples collected. Due to the stiffness of the ground, blade bit drilling would be more suitable when drilling for the first aquifer level. <div style="margin-top: 20px;"> </div> |

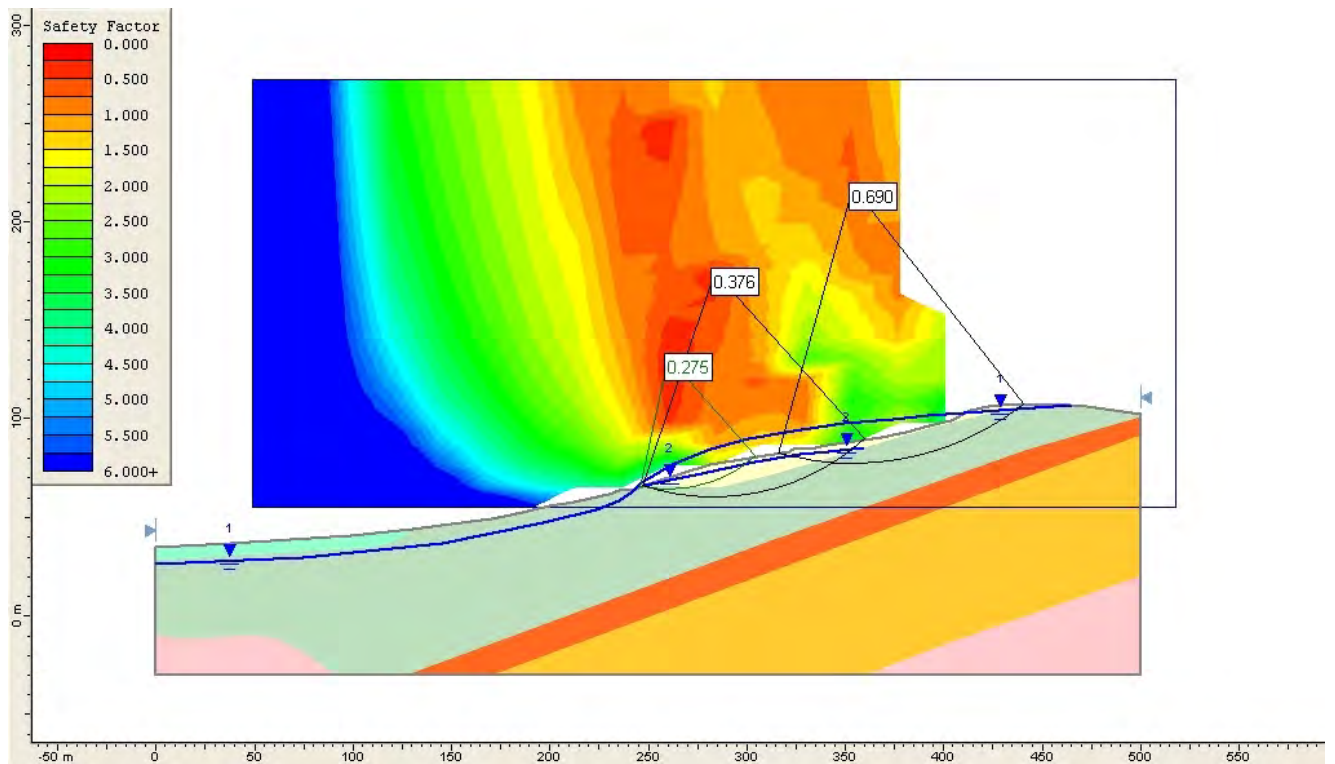
Model A

- ❑ **Model A** starts with maximum groundwater conditions as inferred by MRT comprising artesian pore pressures in the LF2 aquifer and near surface water levels in LF1. The results indicate deep failure through LF2 at a greater depth than the known landslide.

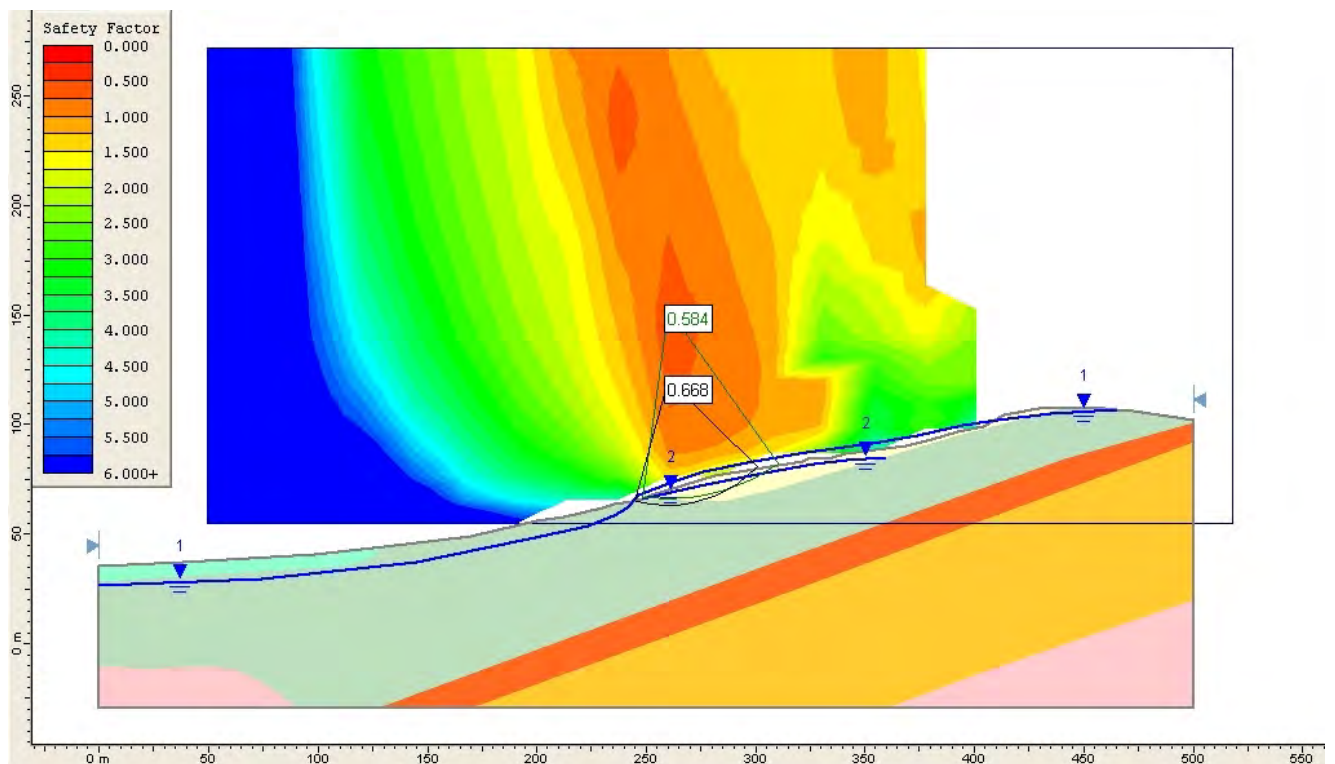
Model B

- ❑ **Model B** has a lower pore pressure in the LF2 aquifer, which results in very low FOS in LF1 materials on the nose of the slide mass, but FOS >1 for larger scale failures through LF2. This scenario is closer to the observed landslide behaviour.

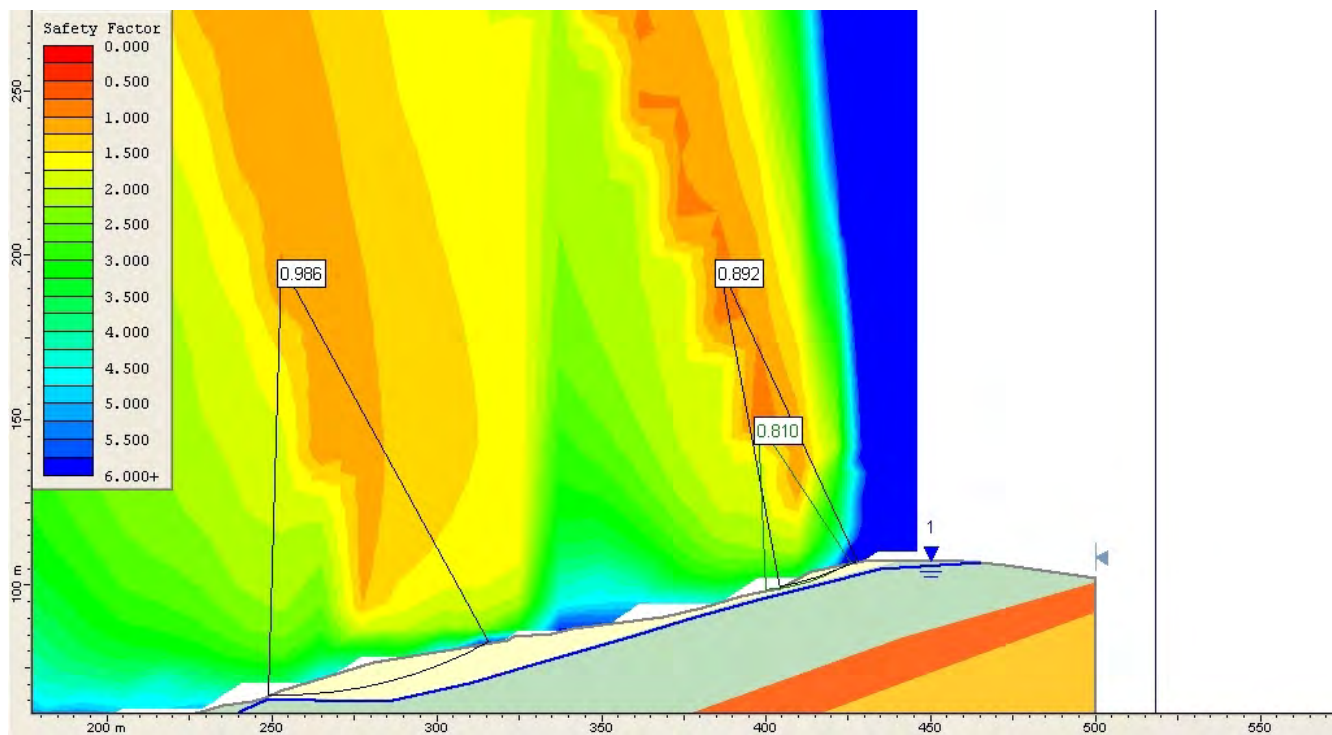
Model E

- ❑ **Model E and F** illustrate that critical circular failure is possible on the existing geometry with the LF1 aquifer drained or part full. The aquifer scenarios shown on Model e and F are approximate to the measured levels in 2005 and 2006, therefore using a homogeneous shear strength of 2 kPa and 11° for the LF1 materials with circular failure planes may not be a reasonable approximation of the actual conditions. Model F also shows how a small rise in water levels at the toe of the LF1 material is sufficient to reduce FOS from approx 1 (equilibrium) to 0.89 (failure).

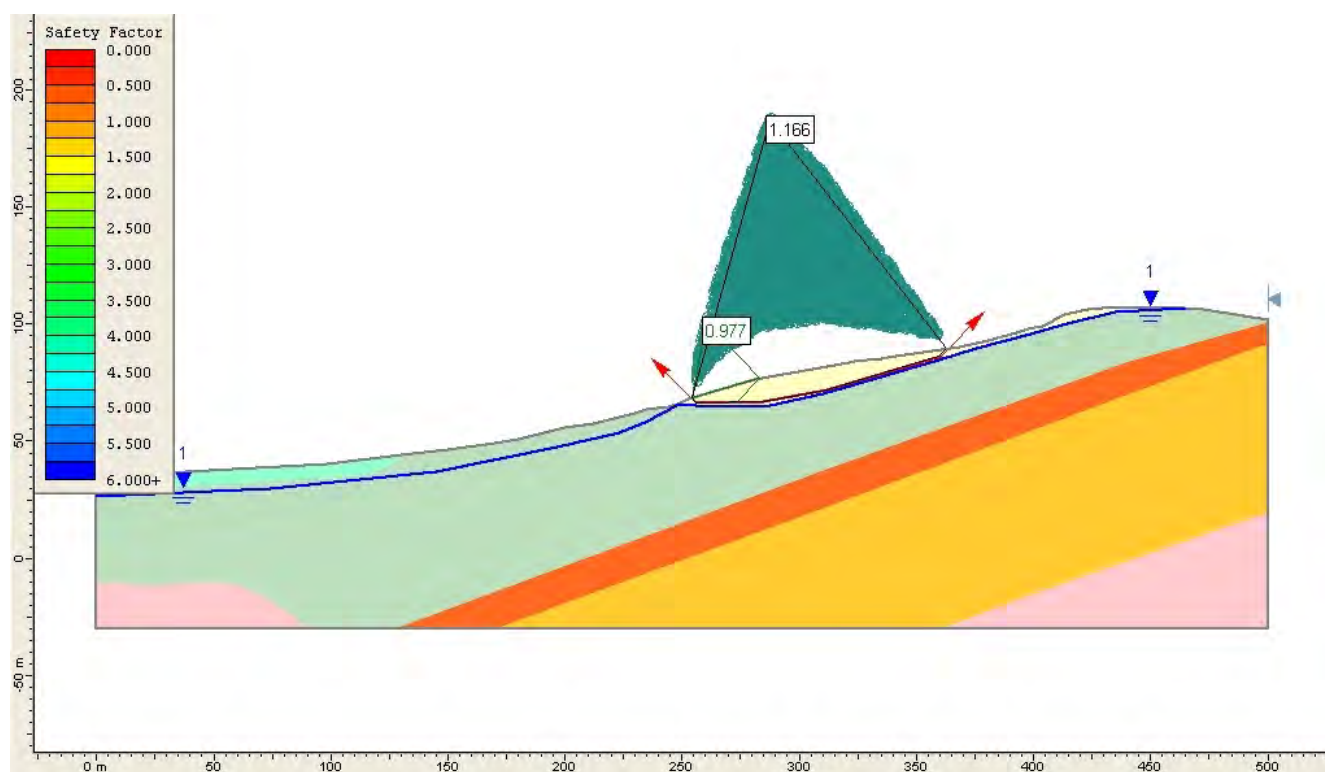
Plane Failure

- ❑ Plane failure considers a scenario based on the following observations –
  - Movement has occurred from full head to toe of the slide mass with the current slope geometry. This is not shown by circular failure analysis.

- Circular failures in homogeneous material indicate movement should be occurring under current conditions where there is no observed movement.
  - Plan failure approximates sliding along residual strength planes at the base of the LF1 unit with break out at the head and toe.

- ❑ Plane failure and plane failure 2 and 3 show basal failure with FOS approx 1 for drained LF1 and LF2 aquifer at the base of LF1. This appears to be reasonable approximation of the existing ‘in equilibrium’ state of the landslide.

Modelling of plane failure in the LF1 material with a shear strength of cohesion 2 kPa and friction 11°, and the above groundwater conditions gives a reasonable approximation of the existing conditions.

The analysis indicates that maintaining drained conditions, via slot drains in the toe of the landslide mass and down slope into the LF2 units is critical to preventing future movements of the landslide.

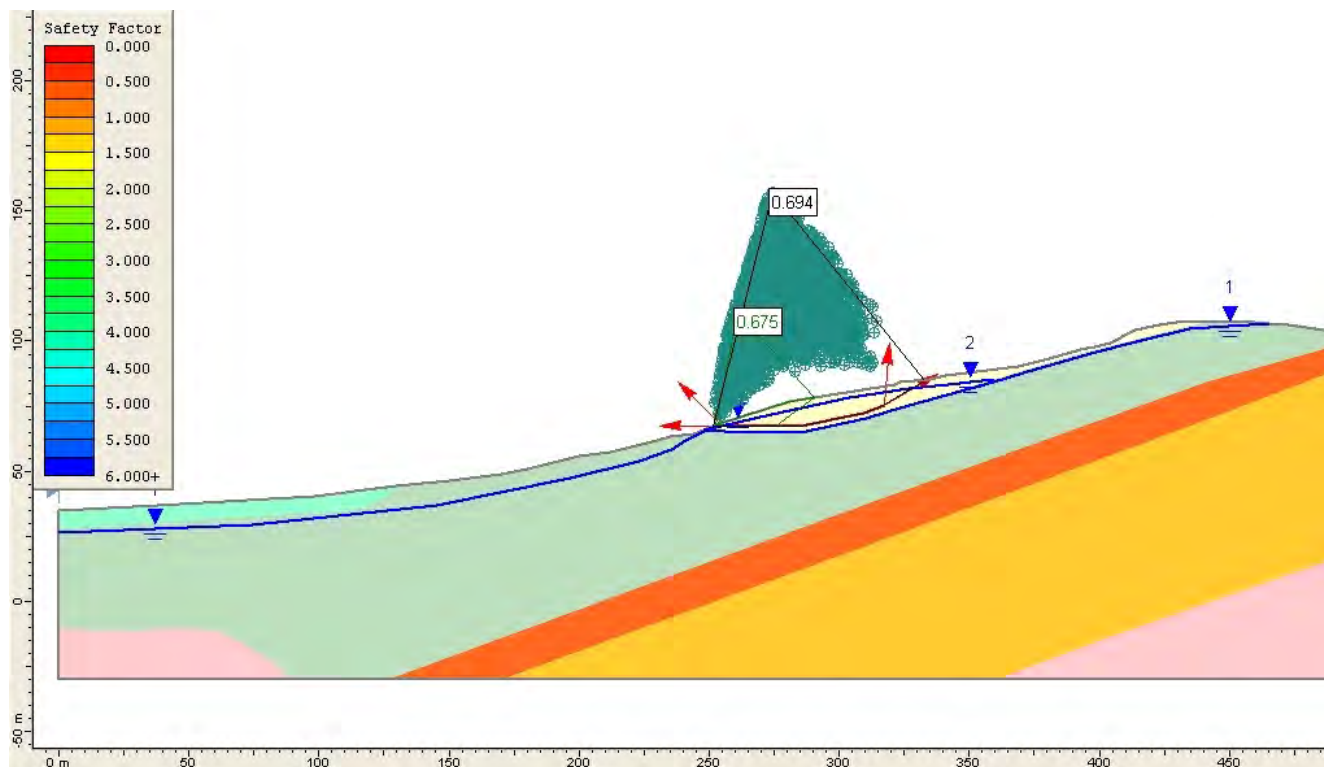
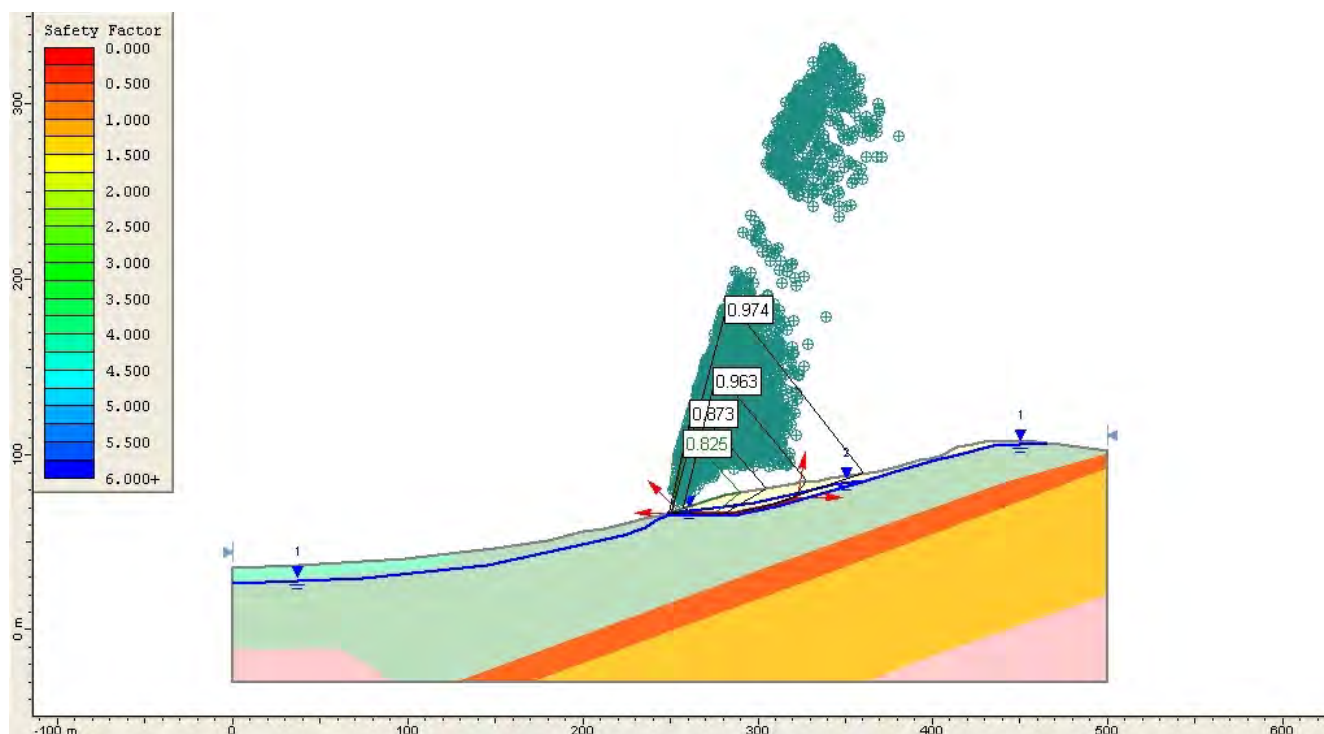
- ❑ Plane failure 4 and 5 show similar sensitivity of planar failures to circular failures with regard to increasing water levels in the LF1 aquifer.
